**Mercury Contamination,
Rutherford/Coupland 1 Building,
University of Manchester**

OH/2009/09

HSL report approval: **Ms H Chambers B.Sc. M.Phil. MFOH.**
Date of issue: **5 March2009**
Job number: **JD4800307**
Registry file: **0291604**
Electronic file name: **JD4800307_ManchesterUni_Hg(corr).doc**

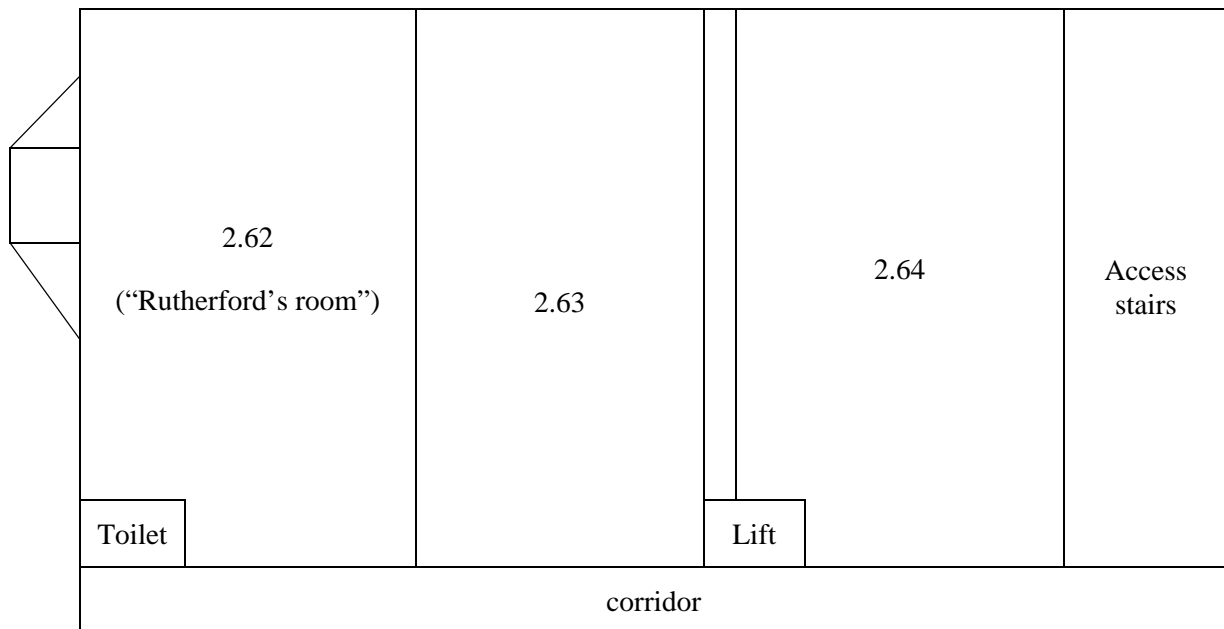
6 APPENDIX - SKETCH PLAN OF SECOND FLOOR

HSL and UOM instruments both showed approximately 1 to 2 $\mu\text{g.m}^{-3}$ in room 2.62, less than 1 $\mu\text{g.m}^{-3}$ at cracks in the skirting board at the bay-window end of the room, but 90 $\mu\text{g.m}^{-3}$ in the entrance doorway at a crack where the wood floor abuts the corridor. Similar concentrations were measured at a hole in the skirting where heating pipes ran through to 2.63, but it was not clear whether this airflow was emerging from beneath the floor or within the studding wall. This wall was made of noticeably lightweight materials, suggesting relatively recent construction.

In room 2.63 the airflow emerging from heating pipe holes (from 2.62) was measured at 200 to 360 $\mu\text{g.m}^{-3}$, other floor/wall join measurements were 13 to 16 $\mu\text{g.m}^{-3}$, but a measurement at approximately 1.5 metres in the room (head height when seated) was consistently 18 $\mu\text{g.m}^{-3}$. Room 2.63 was occupied by 2 or 3 staff.

Mercury vapour was found to be below 1 $\mu\text{g.m}^{-3}$ in the next room, 2.64, except that 18 $\mu\text{g.m}^{-3}$ was detected in the air current at the entry of the heating pipes from 2.63.
