Report on surveys of the presence of mercury vapour in :

**Rutherford Building (ex-Coupland 1)
Psychology Annex
Manchester Museum**

**& other selected buildings at the
University of Manchester**

March 2009.

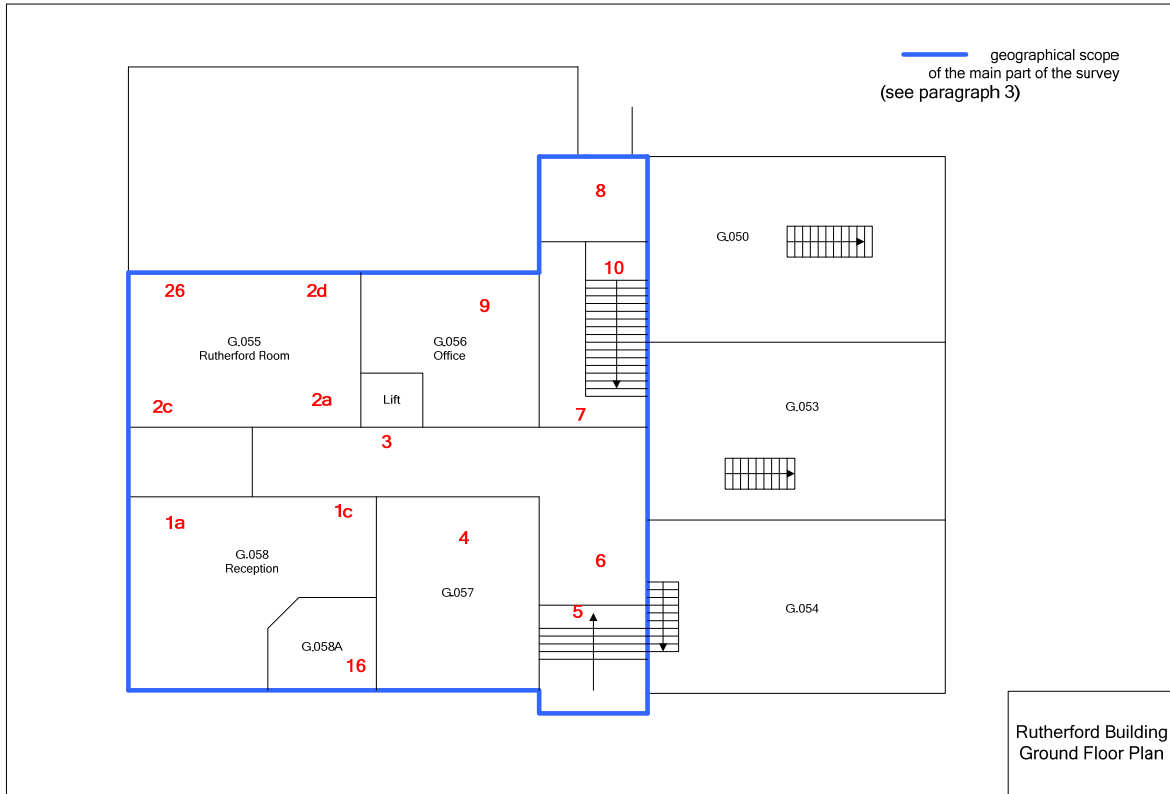
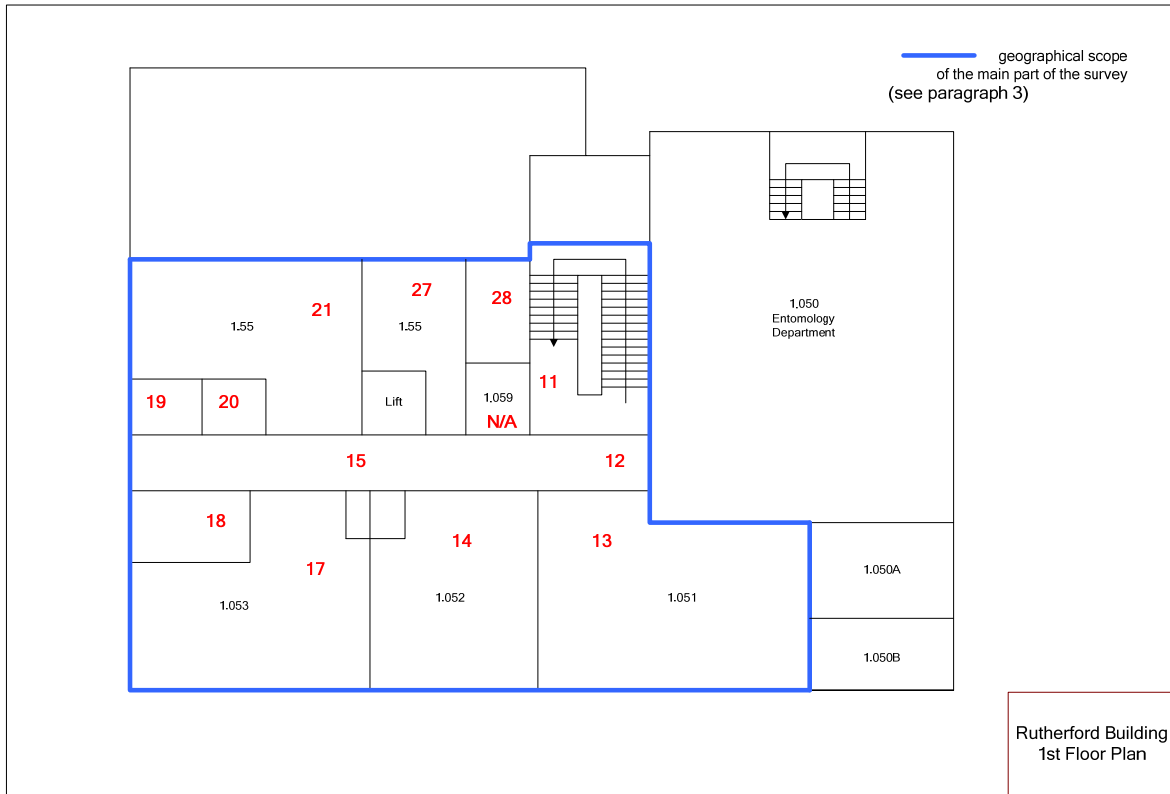
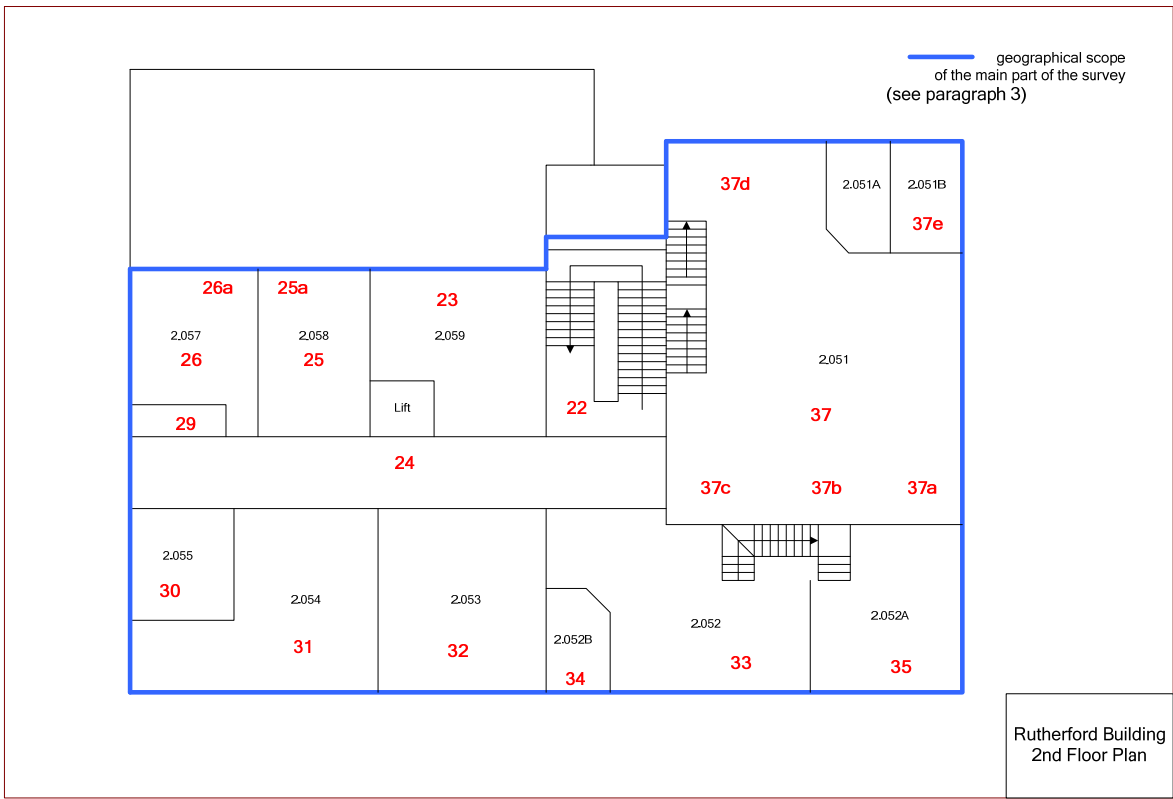
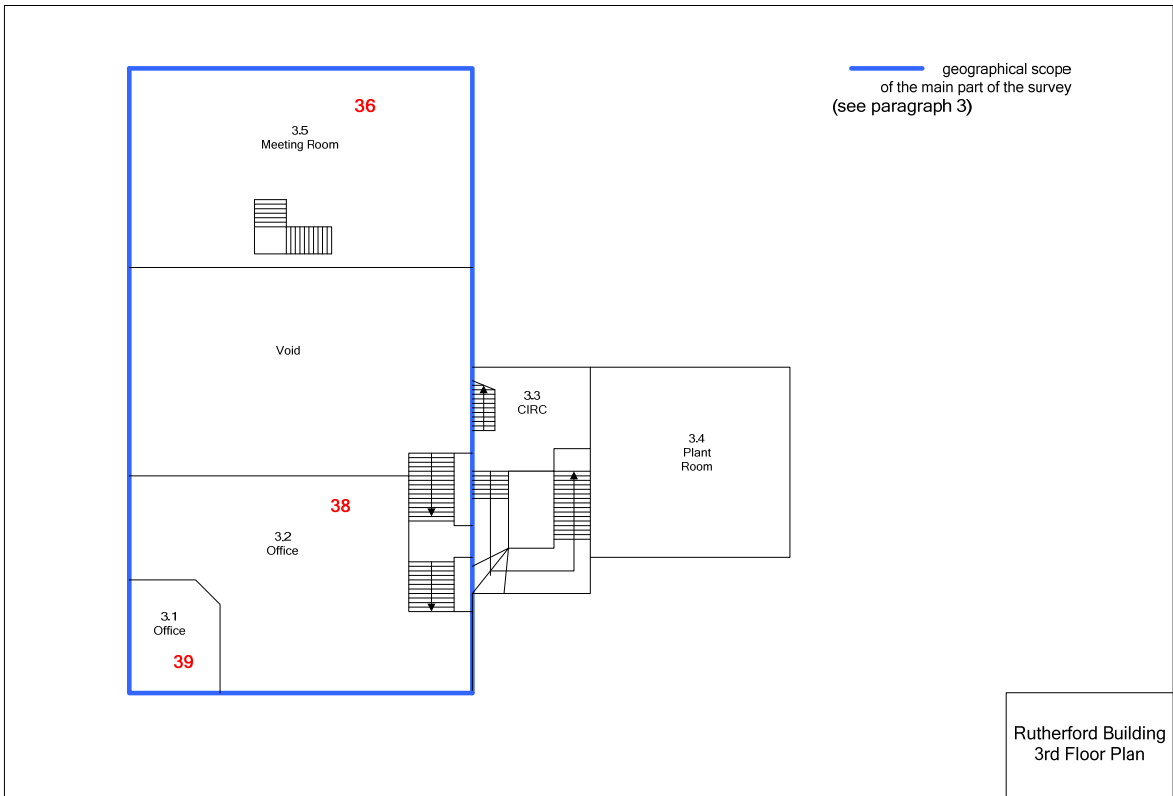
Appendix F Rutherford Building measurement positions

Date	Building / positions	Main findings
2 Sept 2008	Rutherford Building, see plans in Appendix F for measurement positions 1-39	Insignificant concentrations except in Rooms 2.057 & 2.058. In 2.057, at 1.0m (sitting person) height, concentrations 2.7 – 4.5 µg/m ³ ; lower in Room 2.058. But, higher concentrations measured at ground levels, especially near wall/floor junction between rooms, and external wall. Probe pushed behind cupboard unit.
3 Sept 2008	Rutherford Building,	Visit confirmed localised high concentrations behind cupboard unit in Room 2.057.
Specification of work in 2.057 agreed with Estates and contractors, to take up part-floor under existing cupboard unit along party wall (bare floorboards), check for remnants of contaminated material, and remove as much as possible.		
24 Oct 2008	Rutherford, Room 2.057	Continuous monitoring (for mercury and radiation) during work to lift floorboards along party wall to 2.058. For mercury, max at ~1m height in room was 5 µg/m ³ . At ground level, up to 11 µg/m ³ . Between joints (under floor), concentrations ranged from 200-300 µg/m ³ . After work, levels at ground level generally < 5 µg/m ³ but higher around external corner.

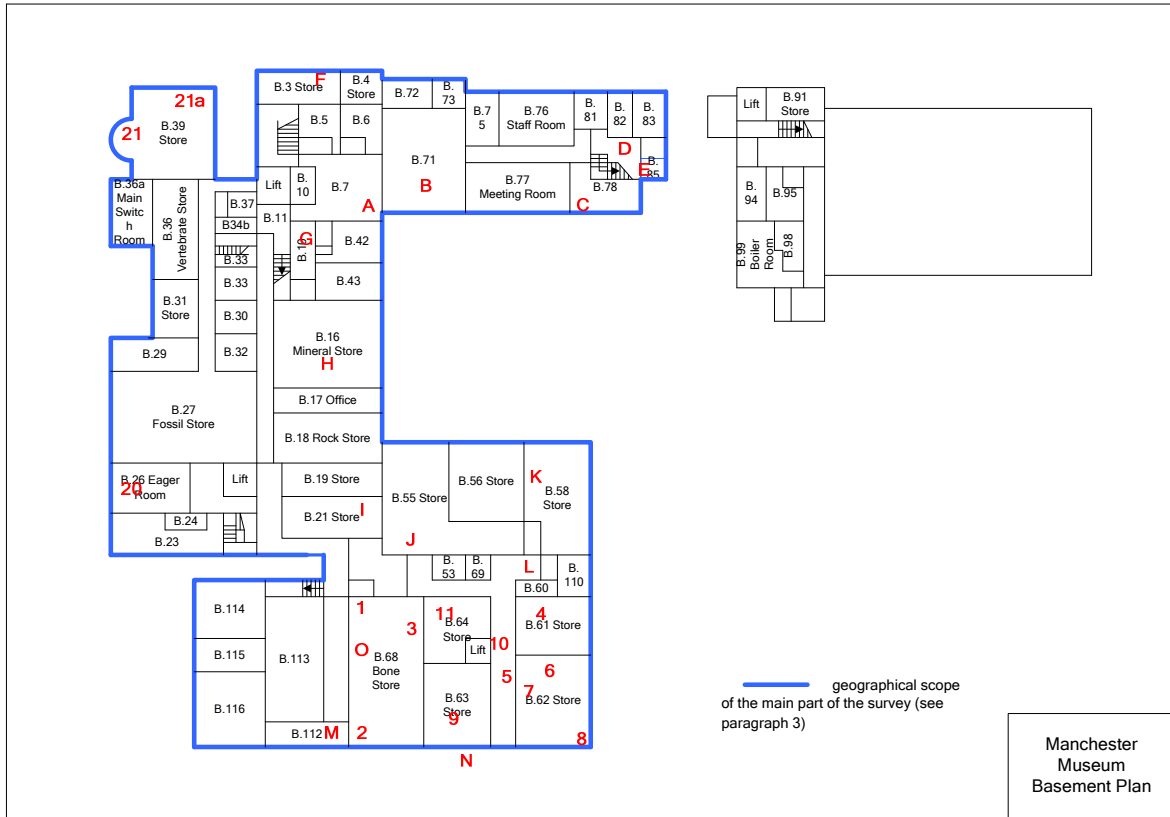
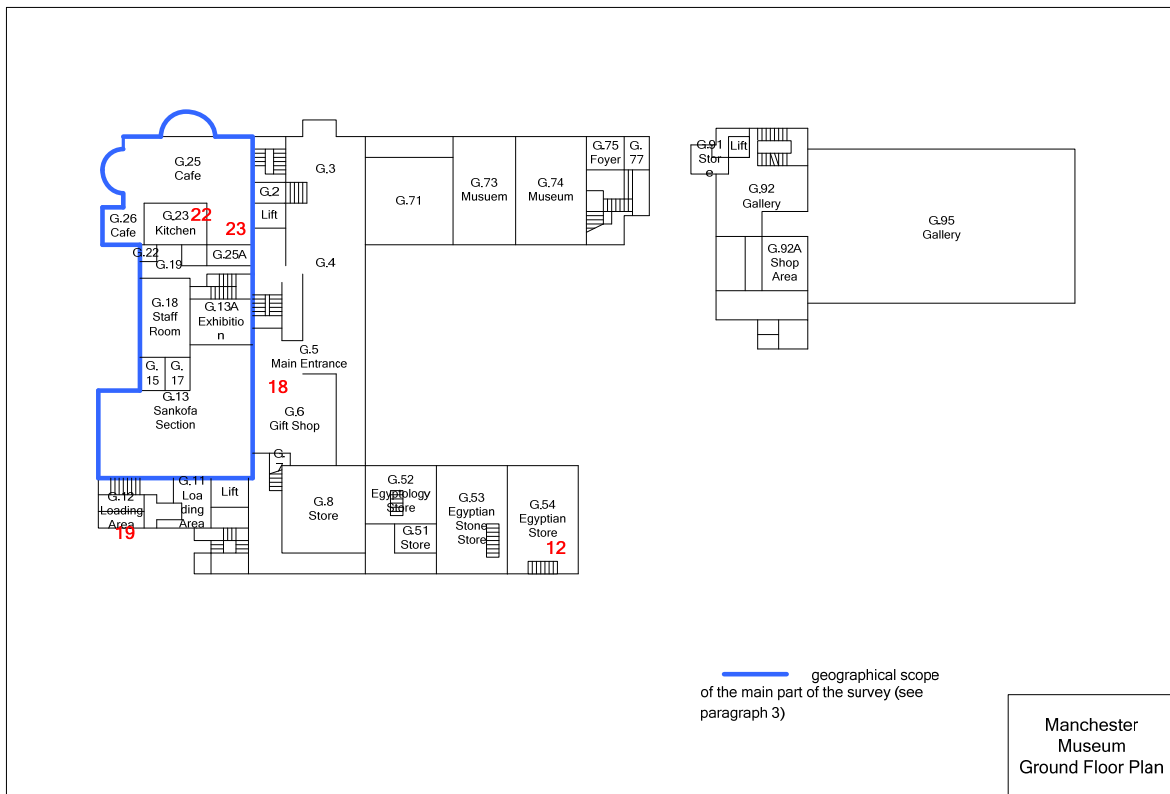
Appendix H Manchester Museum measurement positions

Date	Building / positions	Main findings
13 Aug 2008	Manchester Museum. See Appendix H, plans for measurement positions 1-14, and 15-24 in Old Dental Hospital	Mostly insignificant concentrations, but levels in B62 and B63 up to 13.4 µg/m ³ . Nothing detected in Old Dental Hospital areas.
15 Oct 2008	Manchester Museum See Appendix H, plans for measurement positions A – T.	Mostly insignificant concentrations but levels in B58 reached 25.2 µg/m ³ .
23 Oct 2008	Manchester Museum, B58, B62-3, Entomology	Revisit with Mercury Analyser RA-915+ and MVI. Concentrations found with mercury-specific analyser lower than previously measured with MVI, possibly because of interference by organic hydrocarbons from resinous wood artefacts. At positions 1.5m and 1.0m above ground, range is 1.1 – 8.4 µg/m ³ .
Nov-Dec 2008	Information sought from Museum about pattern of room use, to develop risk assessment.	
Early Feb 2009	<p>Risk assessment finalised on 6 Feb 2009, with main findings and recommendations as follows:</p> <p>In most rooms of the Museum, the mercury vapour levels are low to insignificant, and well below presumed exposure limits averaged over an 8 hour working day. In rooms B58 and B62, concentrations are still well under the WEL, but are elevated compared to other rooms in the Museum.</p> <p>It is known that occupational exposure concentrations are under discussion and are likely to be reduced. It is prudent therefore to reduce exposure to mercury vapour to as low a level as reasonably practicable. For these reasons, the following recommendations are made:</p>

1. The Museum should ensure working patterns do not change such that staff spend more time in rooms B58/B62, (or if they do need to change, this risk assessment should be reviewed).
2. Before any refurbishment, maintenance or repair work involving penetration to any structural element is carried out, specific and local mercury vapour monitoring should be carried out and a specific risk assessment made.
3. Further investigations should be made into the possible sources/location of mercury contamination in B58/B62, with a view to removing it in due course.
