## **Details of a lead block recovered from the attic-space above the Cohen Lecture Theatre, Coupland I Building.**

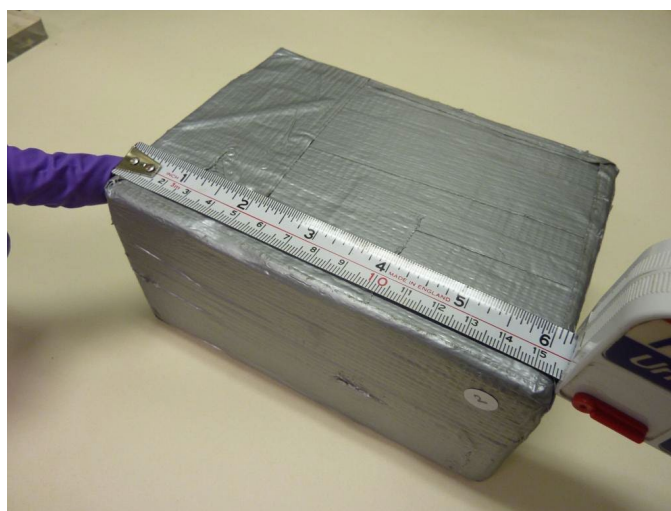
**Figure 1: Lead block retrieved from the roof-space above the Cohen Lecture Theatre, Coupland I Building**

The dimensions of the lead block are 16 x 11 x 8 cm. One of the faces of the block appears to have been hollowed out and then back-filled with lead. Prior to receipt by the RSU, the block had been covered with duct-tape on the five 'intact' faces, and at the time of receipt was verbally described by NIRAS as 'radioactively contaminated'.

Upon receipt of the block by the RSU in May 2005, it was securely stored behind lead shielding in the fume cupboard within the RSU's designated Supervised Area laboratory. Radiological investigation of the block at the time of receipt revealed an uneven radiation dose rate from the six faces, and this was considered to reflect the possibility of variable levels of contamination on each surface. The highest radioactive count rate of 270 counts per second (cps)

above background was obtained on the filled surface (i.e. that which had not been covered in duct-tape prior to receipt by the RSU). The radiation counts at the remaining five (taped) surfaces were considerably less (50 cps above background (faces 1 and 6) and 5-8 cps (faces 2,3 and 4) (see Appendix 1).

As an item of radioactive waste, the university would wish to dispose of this material to an approved contractor at the earliest opportunity, but there is currently no provision for this within the university's Permit under the Environmental Permitting Regulations 2010 (EPR10). The university is therefore required to apply to the Environment Agency for a variation of its Environmental Permit, a process that is currently in progress. The Environment Agency has also requested the university to provide them with details of (i) the physical nature of the embedded radioactive material (Radium 226) embedded in the lead block, (ii) the activity of the Radium 226 source embedded in the lead block, (iii) identification of a disposal route for the radioactive waste, and (iv) details of the contractor who has been contacted to arrange the disposal of the radioactive waste. These requests are currently being addressed.

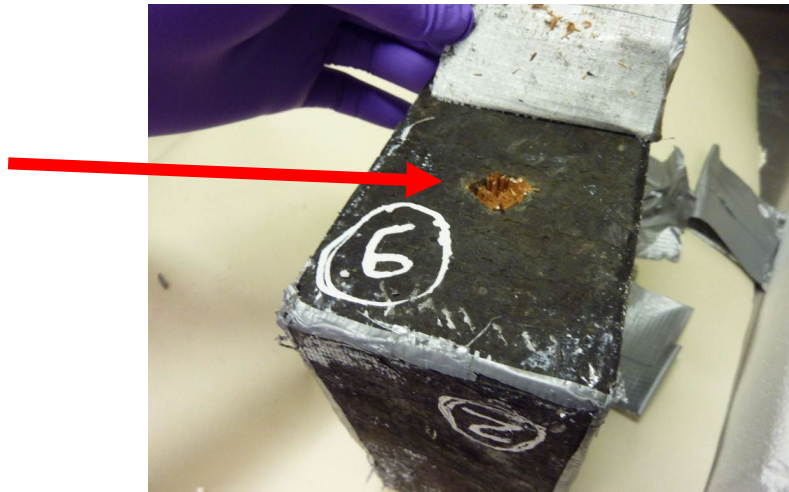
**Figure 2: Face 6 of the Lead block after removal of surface tape, showing evidence (arrowed) of a wooden insert.**

Interestingly, removal of the surface tape has revealed evidence of a wooden insert on one of the faces (see *Figure 2*); there is no evidence of any enhanced radioactivity associated with this area.

Face 6 = 40 to 50 cps above background.
