Preliminary Contamination Survey

Rutherford Building Lecture Theatre and Other Lofts

Our Reference **SERCO/TS/SRS/P7369.3 R4 Issue 02**

24th September 2010

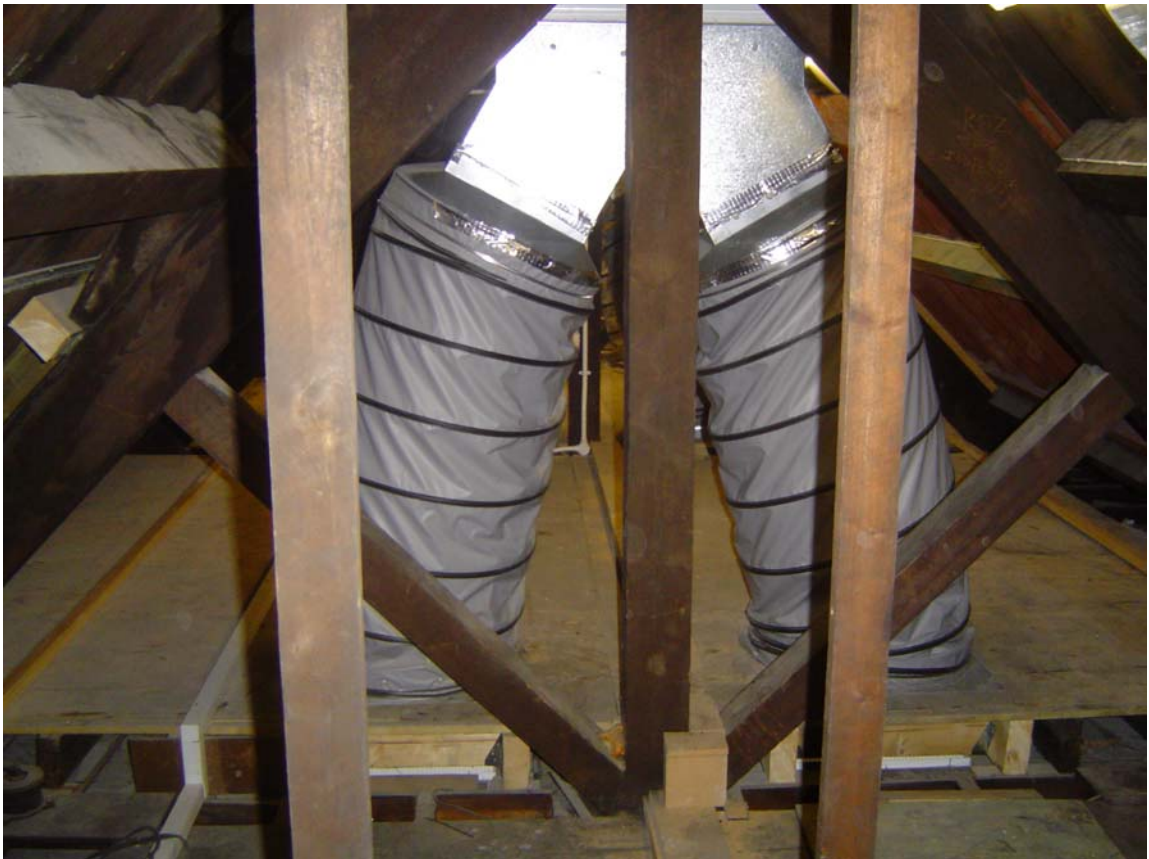
Figure 1. View of AC ducts Looking from Section 1 into Section 2

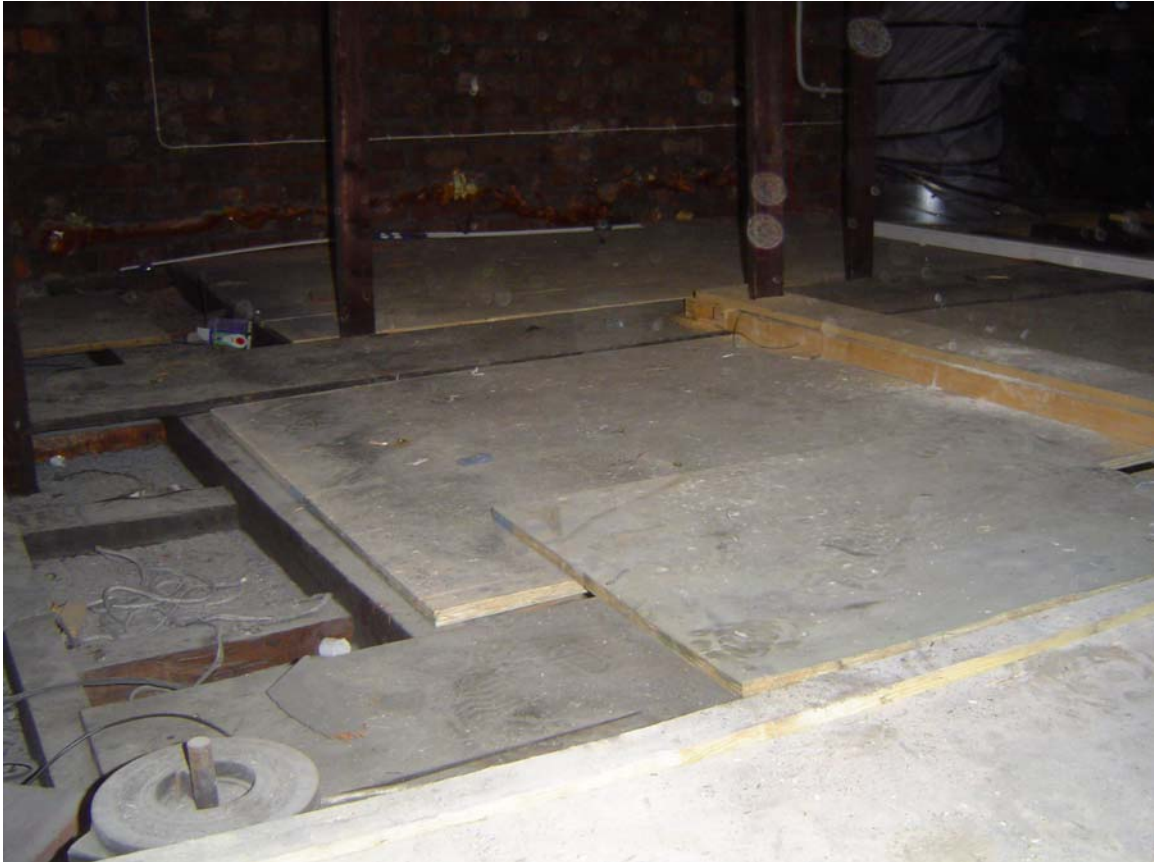
Figure 2. View of Section 4 of Lecture theatre loft

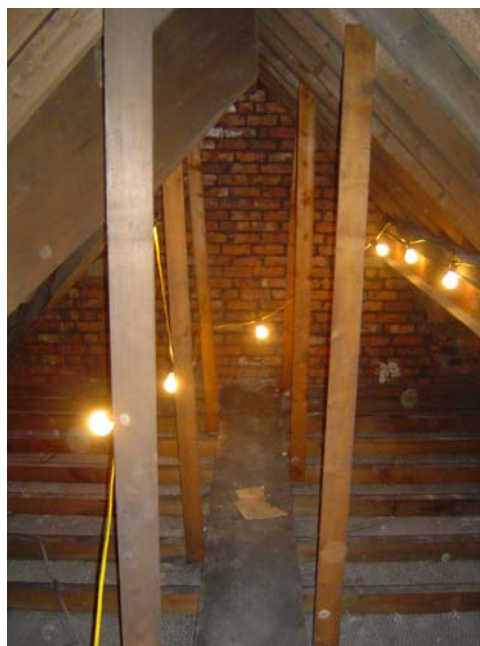
The attic space rooms M2.002, 2.054, 2.053 and 2.052 are unused spaces above those rooms. Each attic space has a central wooden walkway below which is the ceiling of the room below, with no insulating material. Figure 3 shows the typical condition of these lofts.

Figure 3. Rm 2.054 Loft

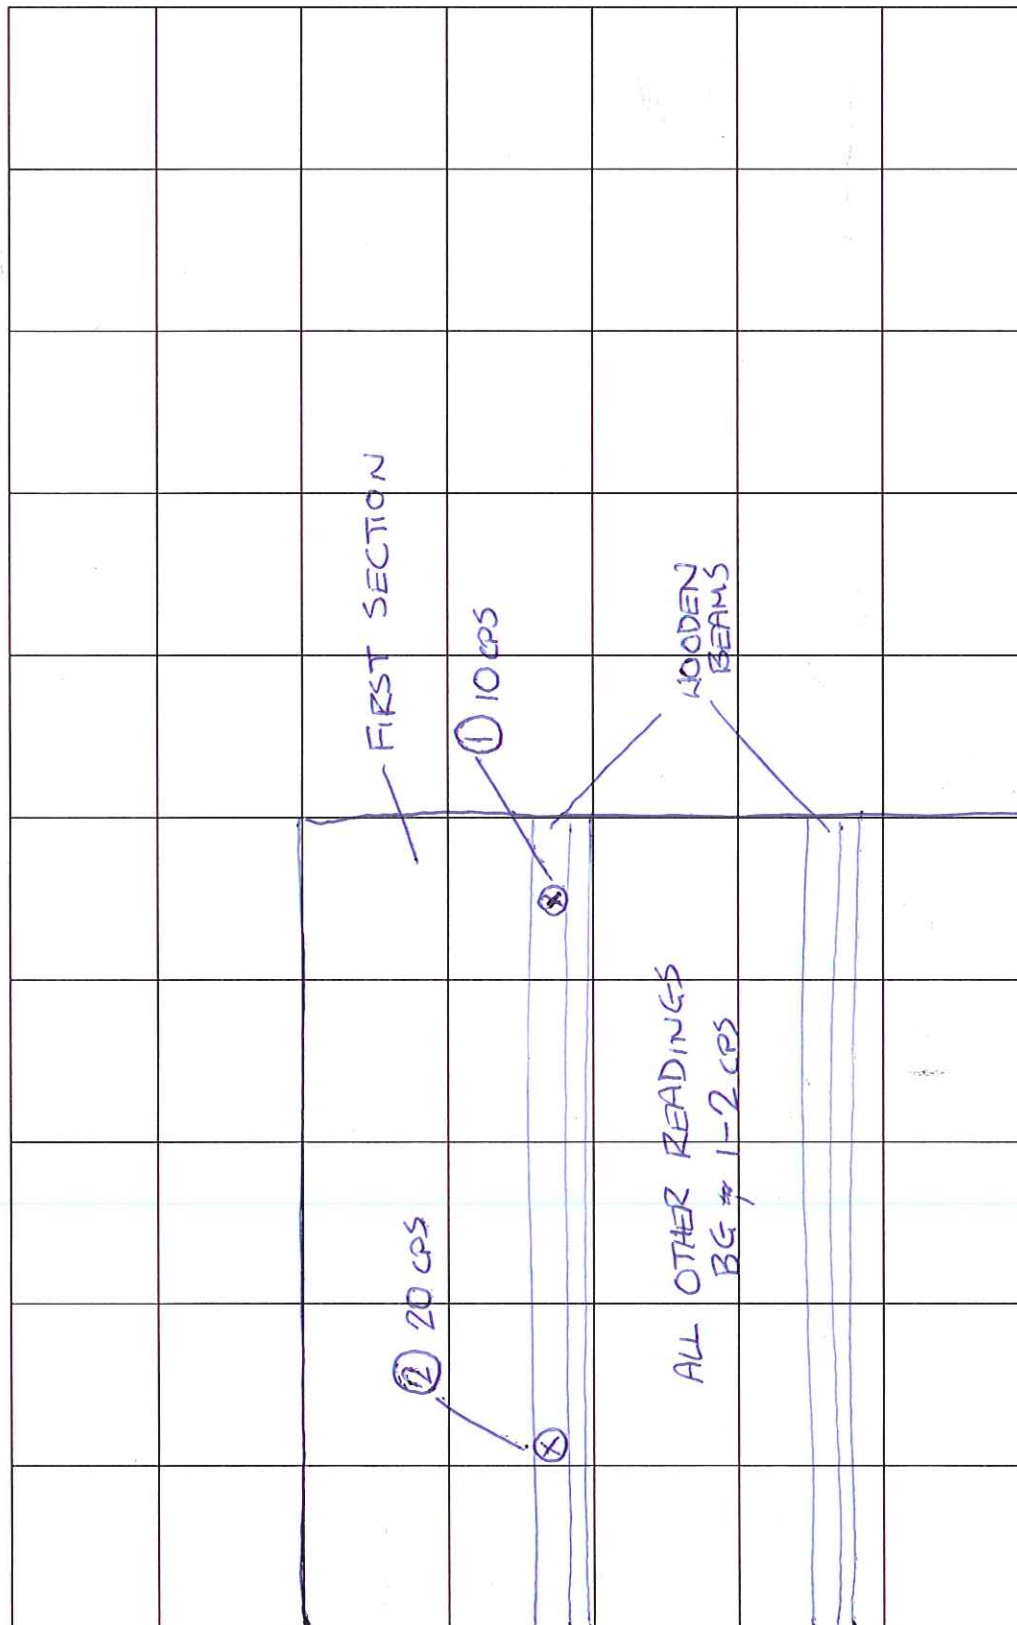
SHEET 4 OF 13

Location	Survey Sheet Ref. (Appendix A)	EP15 Reading (cps)	Activity (Bq)*	Description of Location
Lecture Theatre Loft	Point 1 (Sheet 4)	10	20.9	On top of Wooden Beam
Lecture Theatre Loft	Point 2 (Sheet 4)	20	41.8	On top of Wooden Beam
Lecture Theatre Loft	Point 3 (Sheet 5)	25	52.3	On top of Wooden Beam
Lecture Theatre Loft	Point 4 (Sheet 8)	7	14.6	On top of Wooden Beam
Lecture Theatre Loft	Point 5 (Sheet 10)	20	41.8	Plywood Floor
2.054 Loft	Point 1 (Sheet 1)	10	20.9	Wooden Floor Joist

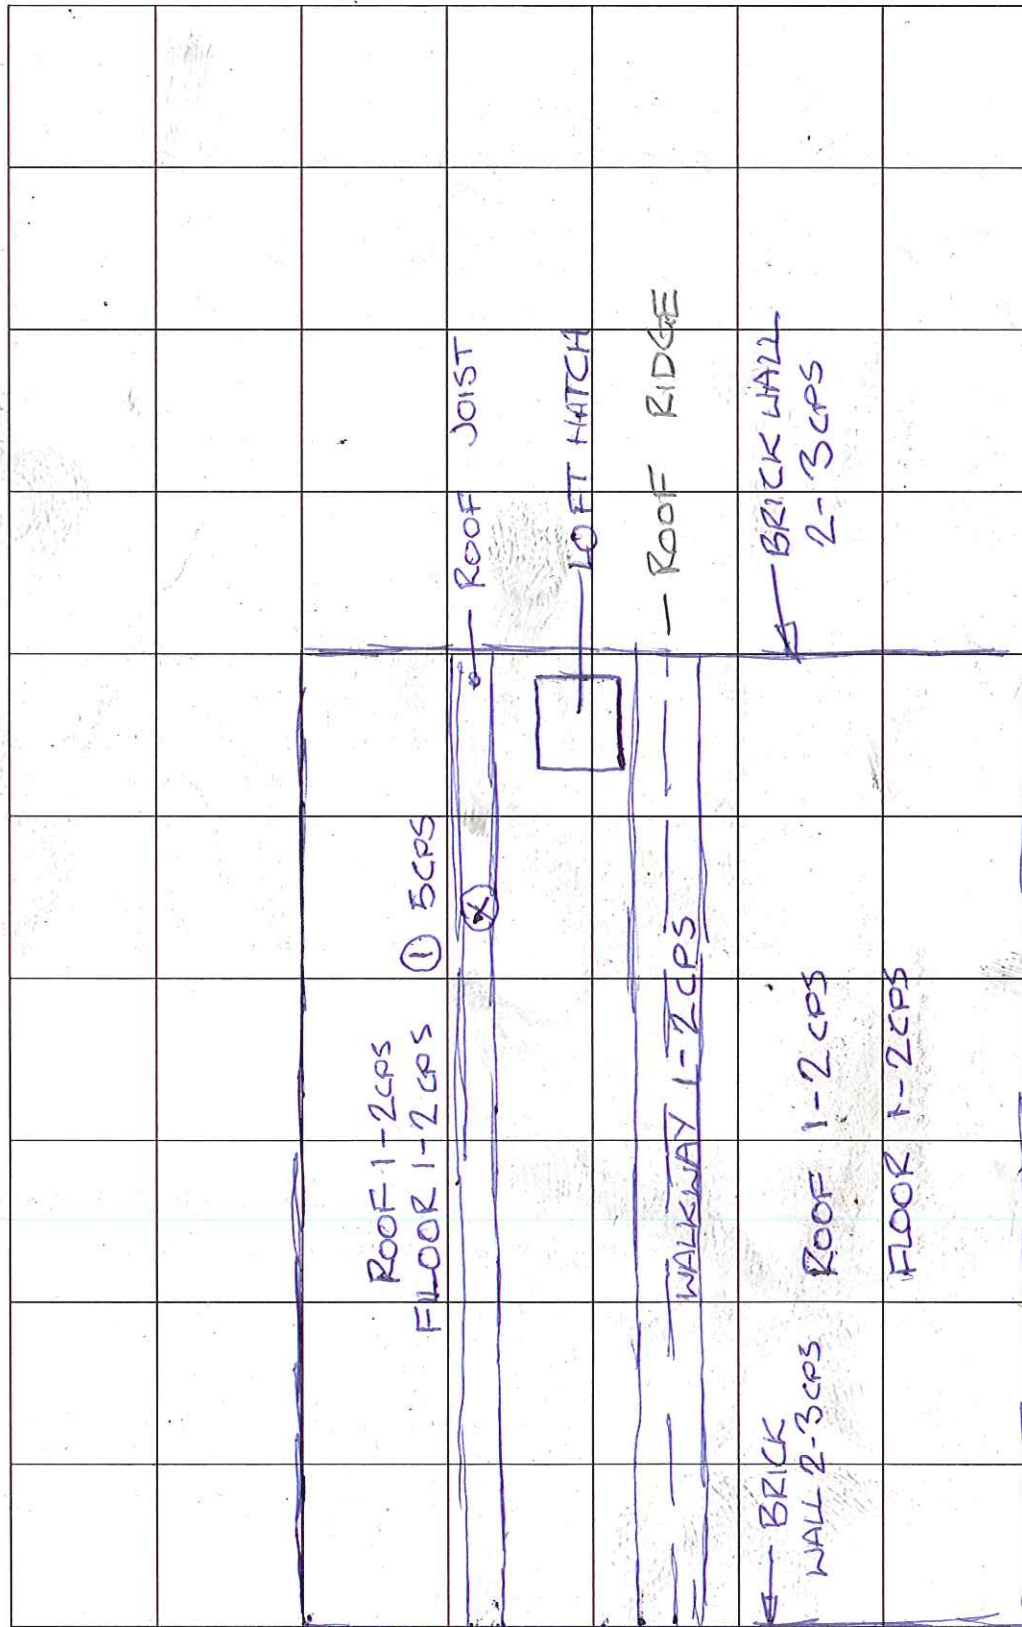
Location	Survey Sheet Ref. (Appendix A)	EP15 Reading (cps)	Activity (Bq)*	Description of Location
2.053 Loft	Point 1 (Sheet 1)	30	62.7	Wooden Roof Joist
2.052 Loft	Point 1 (Sheet 1)	5	10.5	Wooden Roof Joist
