**INVESTIGATION OF POSSIBLE MERCURY  
CONTAMINATION WITHIN 3 LOCATIONS AT THE  
UNIVERSITY OF MANCHESTER**

**THE UNIVERSITY OF MANCHESTER  
COUPLAND 1 BUILDING<sup>i</sup>**

| <b>Report No:</b> | <b>11826.2 amendment</b> | <b>Client Ref:</b> | <b>Mercury Monitoring</b> |
| <b>Survey Date:</b> | <b>18<sup>th</sup> February 2010</b> | <b>Site Contact:</b> | <b>Mr Alan Lee</b> |

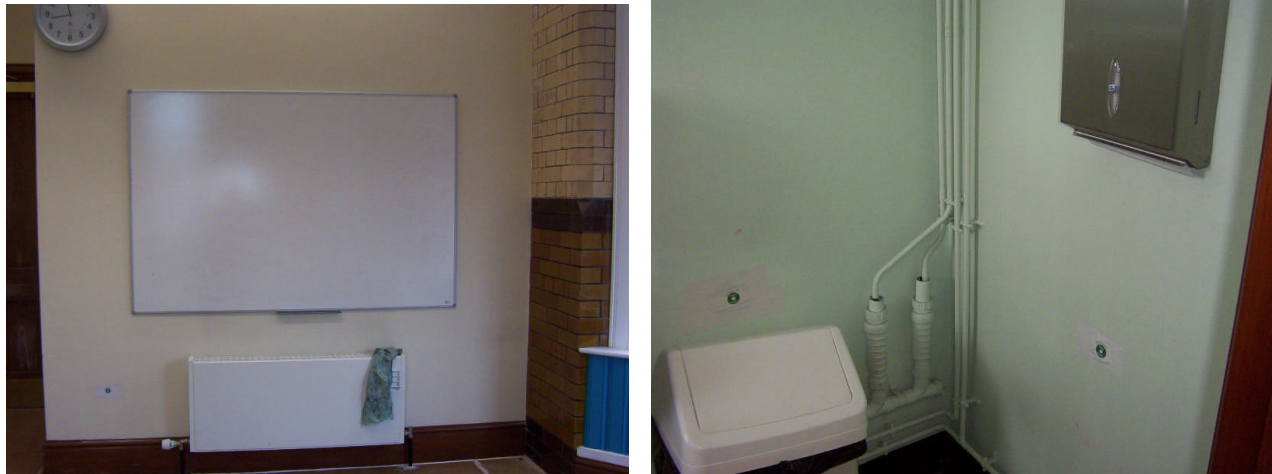
**Partition Wall 2.58 / 2.62**

Pilot holes were drilled either side of the toilet partition wall 2.58 into room 2.62. The Mercury Vapour Monitor was then inserted and readings indicated zero.

| Room | Location | MERCURY <sup>1</sup> EXPOSURE | |
|---|---|---|---|
| Room 2.62 to 2.58 – Main partition wall | Pilot hole 1 - Above the plastic ducting at 0.3m height. Bulk sample M19 | Nil | - |
| Room 2.62 to 2.58 – Side partition wall | Pilot hole 2 - Above the plastic ducting at 0.3m height. Bulk sample M20 | Nil | - |
| Room 2.58 to 2.62 – Main partition wall | Pilot hole 3 - Above the plastic ducting at 0.3m height. Bulk sample M21 | Nil | - |
| Room 2.58 to 2.62 – Side partition wall | Pilot hole 4 - Above the plastic ducting at 0.3m height. Bulk sample M22 | Nil | - |

No mercury vapour was detected in the walls of room 2.58 and also no contamination within the bulk samples was found. It should be noted however that removal of this partition wall may impact on older possibly contaminated building fabric and any risk assessment for the removal of this wall should take this into account.

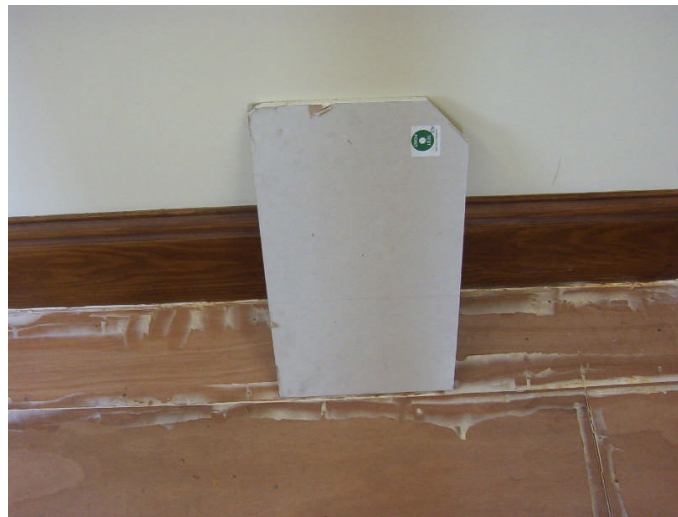
**Miscellaneous plasterboard**

The bulk sample taken from the miscellaneous piece of plasterboard was found to be below the limit of detection for mercury contamination.

It should be noted that the photograph of the plasterboard was photographed in Room 2.62, but was tested in room 2.63.

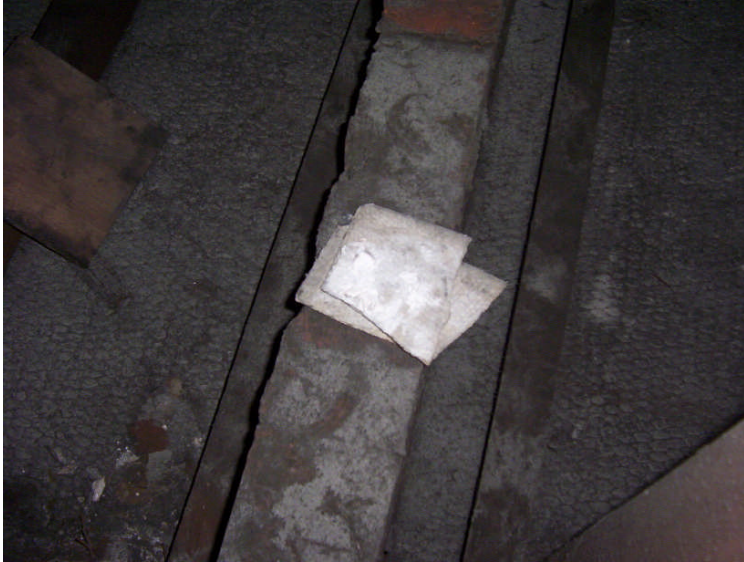
Two samples were taken for possible Asbestos Containing Materials (ACM's) within the loft area. The first was a cement tile broken into two pieces, this was identified as chrysotile. The entire tile was removed and disposed of by ALcontrol. The second material was the decayed insulation from the redundant pipe, no asbestos was detected.

| Location | Suspected material and sample no. | Analysis result |
|---|---|---|
| Room 2.62 & 2.63 Loft | Cement tile broken into two pieces (sample A1) | Chrysotile asbestos confirmed |

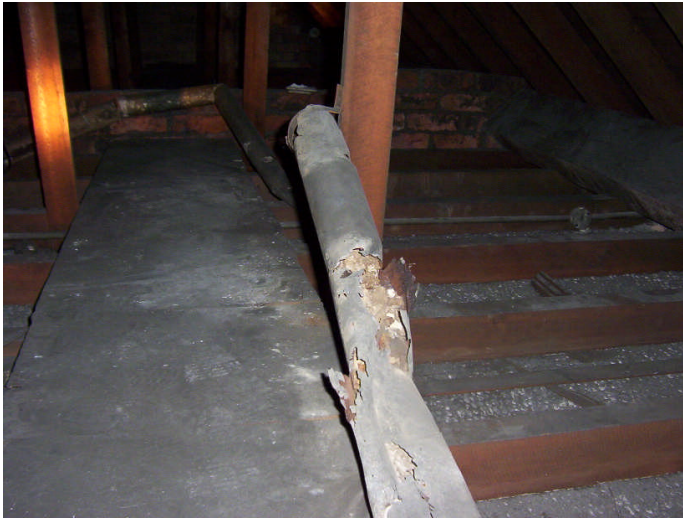
| Location | Suspected material and sample no. | Analysis result |
|---|---|---|
| Room 2.62 & 2.63 Loft | Decayed insulation within pipe covering (sample A2) | No asbestos detected |
