**INVESTIGATION OF POSSIBLE
MERCURY CONTAMINATION WITHIN
ROOF VOIDS AT THE UNIVERSITY
OF MANCHESTER**

**THE UNIVERSITY OF MANCHESTER
COUPLAND 1 BUILDING**

Report No:	11826	Client Ref:	Mercury Monitoring
Survey Date:	June 2010	Site Contact:	Mr Alan Lee
Report Date:	August 2010	Server Reference:	Occupational Hygiene Special Projects 2010

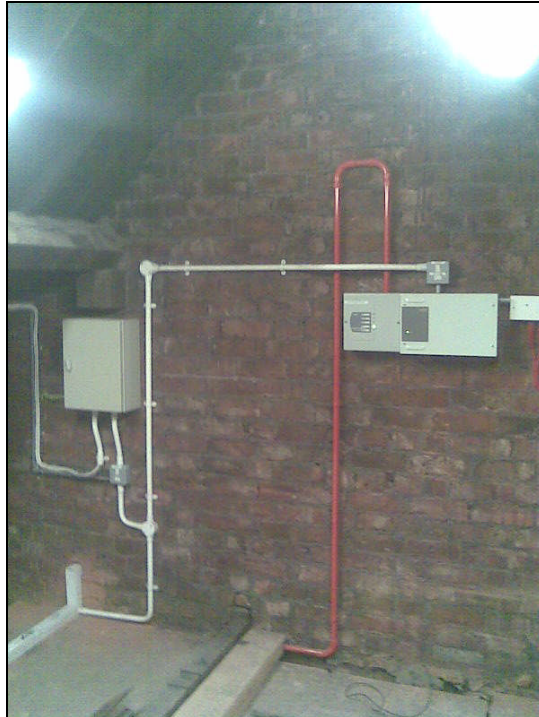
There are modern wiring systems and fire alarm systems within the loft areas where University of Manchester staff or contractors may need access for maintenance purposes.

Photograph showing modern fire panel in roof void above 3.04 where University of Manchester employees or contractors may need access

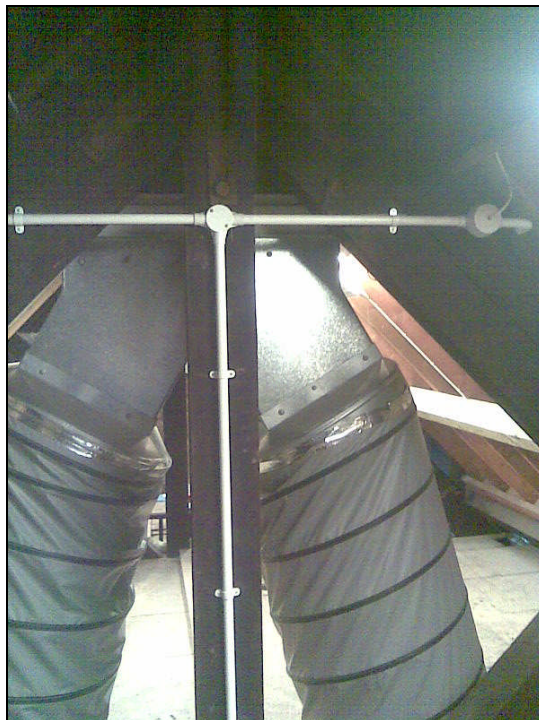
Photograph showing AHU ducting serving room 2.51

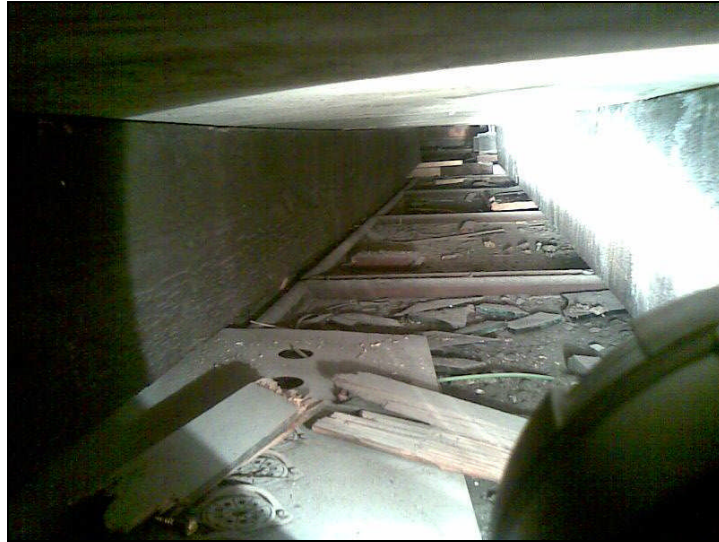
There were suspended floors in the roof void above room 3.04. It was observed that there were high levels of detritus under these floor sections but access was not possible to determine if any mercury was present. It should be noted however that no mercury vapour was detected in the main loft area and it would be highly unlikely that any mercury would be present in these areas.

There was an area of no access within the loft above room 3.04 but given the results for the rest of the loft and the distance of this location from the dominant source of mercury contamination within the building it is very unlikely that any mercury will be present under the suspended floor area.

Photograph showing debris under suspended floor in roof void above Room 3.04

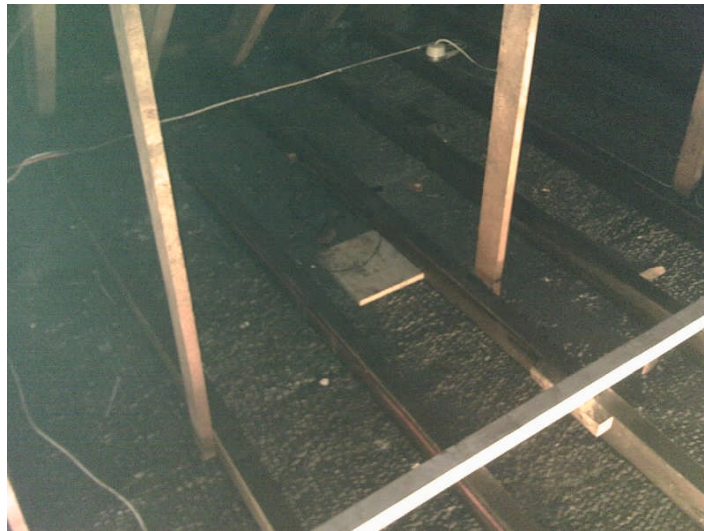
Photograph showing exposed plaster and wiring conduits in roof void above Room 3.03

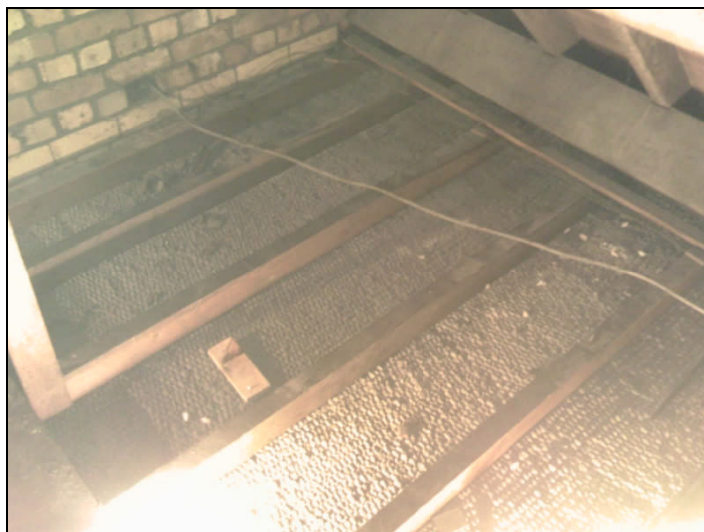
Photograph showing exposed plaster and old wiring within roof void above room 2.53

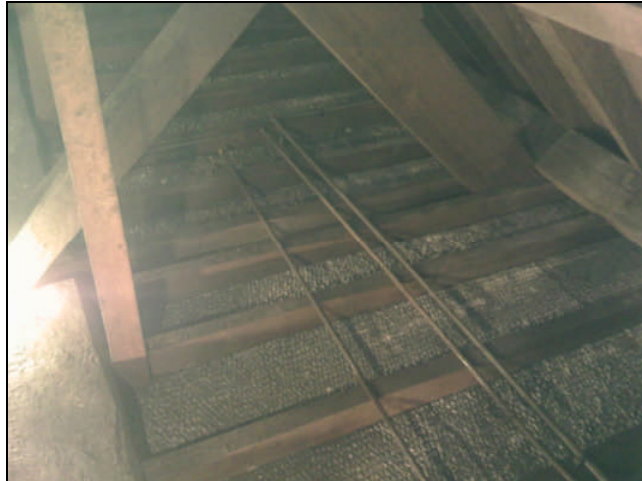
There were old cable trays and cables present within the loft areas but all wiring was disconnected.

Photograph showing redundant cables within the roof void above room 2.55

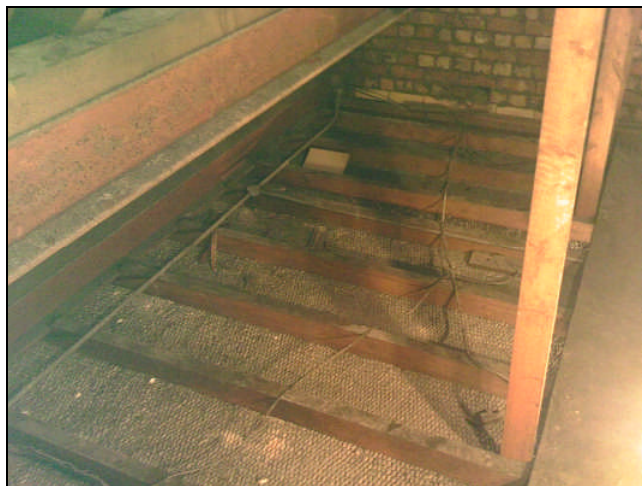
Photograph showing redundant cables RSJ within the roof void above room 2.54.
