# **Rutherford Update**

Dr David Barker  
Head of Compliance and Risk  
University of Manchester

29th September 2010

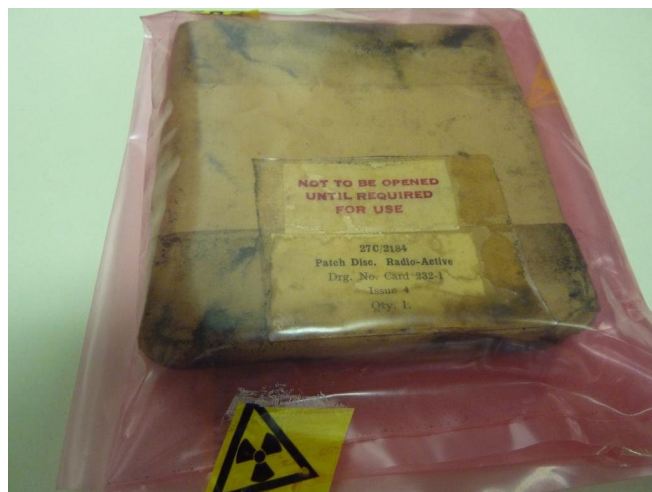
Contained within the RPS safe is an item described in February 2010's cataloguing as a "patch disc". Andrew Frith has now confirmed that this is indeed the source that was removed from the attic. The item is approximately 10cm square, is thought to be part of a piece of apparatus and estimated to be of 1960s origin. The "patch disc" is illustrated in Photo 1 below:

Photo 1: “Patch disc” source confirmed as having been removed from the attic above the Cohen Lecture Theatre, 4<sup>th</sup> August 2005
