# **RADIATION SURVEY OF COUPLAND 1 BUILDING UPON COMPLETION OF SOFT STRIPPING**

December 2004

**E04003/TR/002  
Issue 01**

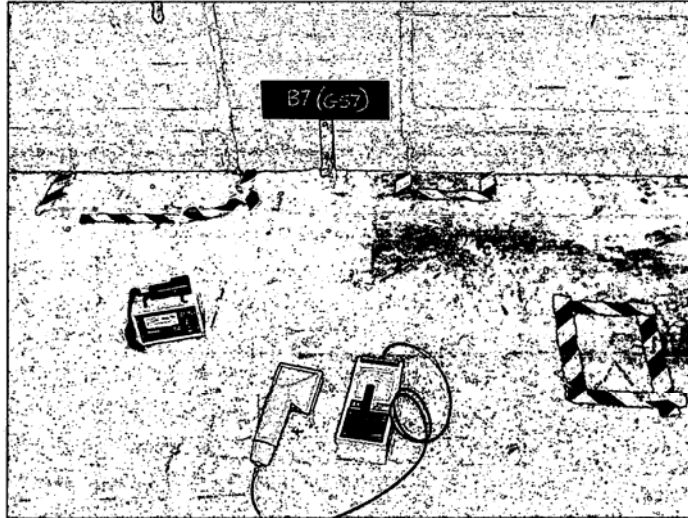
### 6.1 Contaminated Areas in G57 (B7)

| Room | Coordinate | Identifier | Alpha cps | Beta cps | Gamma cps |
|---|---|---|---|---|---|
| G57 (B7) | F (5,2) | A | 1 | 7 | 5 (=bgd) |
| | F (6,2) | B | 0.5 | 8 | 5 (=bgd) |
| | F (5,3) | C | 0 | 6 | 5 (=bgd) |
| | F (6,3) | D | 0 | 10 | 5 (=bgd) |

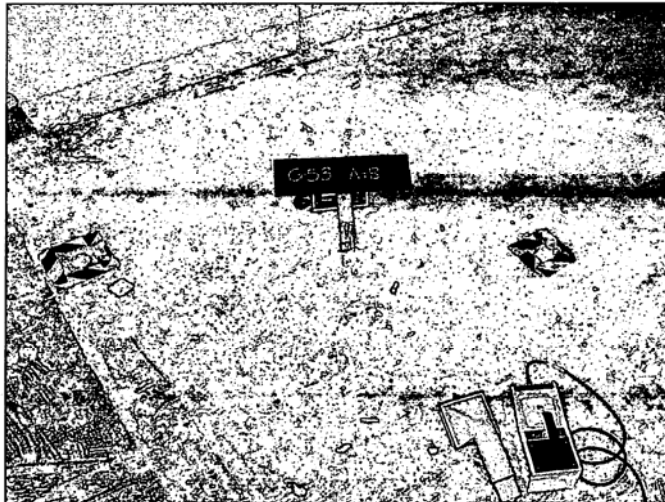
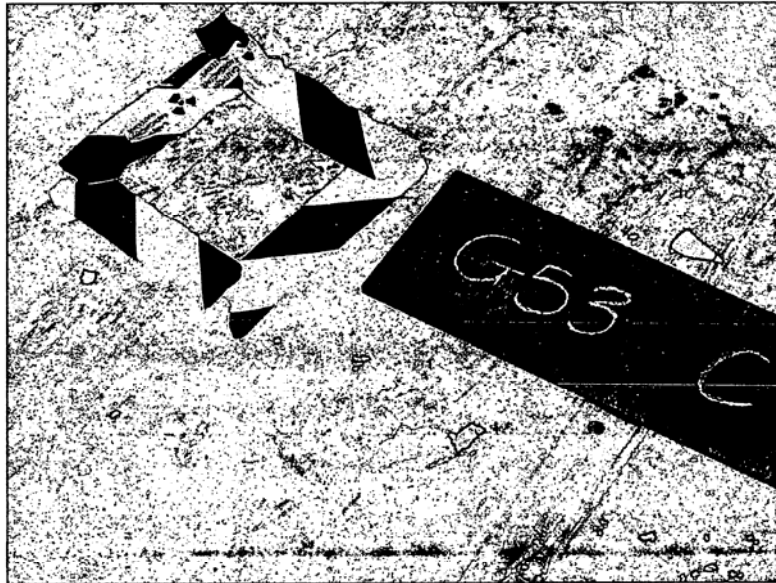
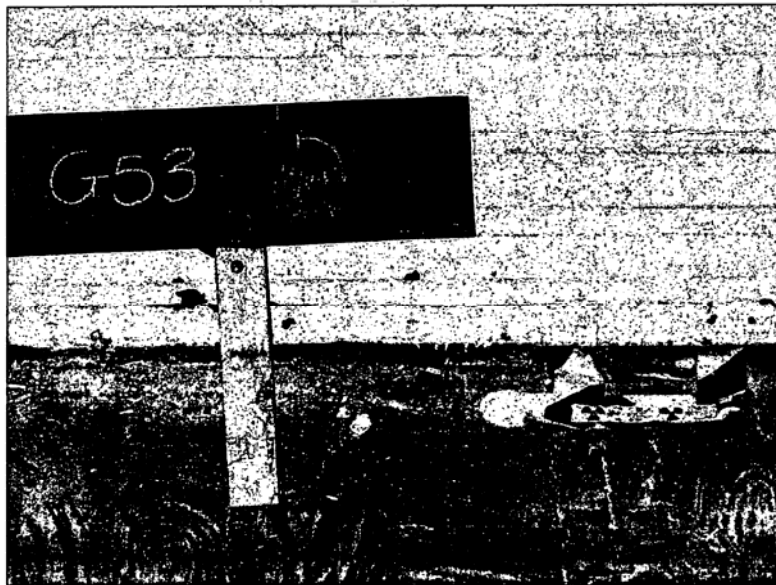
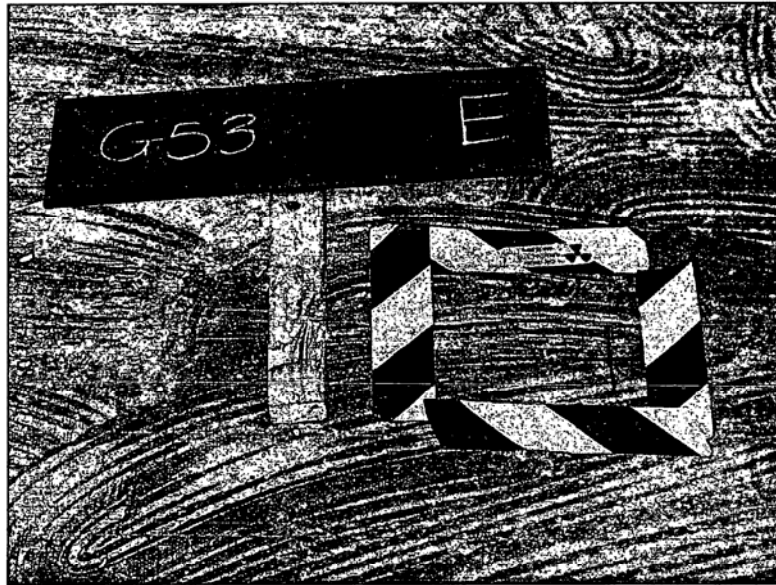
### 6.2 Contaminated Areas in G53

| Room | Coordinate | Identifier | Alpha cps | Beta cps | Gamma cps |
|---|---|---|---|---|---|
| G53 | F (8,3) | A | 0 | 15 | 7 |
| | F (7,2) | B | 0 | 5 | (4-5 =bgd) |
| | F (7,0) | C | 0 | 10 | (4-5 =bgd) |
| | F (7,6) | D | 0 | 8 | (4-5 =bgd) |
| | F (1,2) | E | 0 | 15 | 10 |

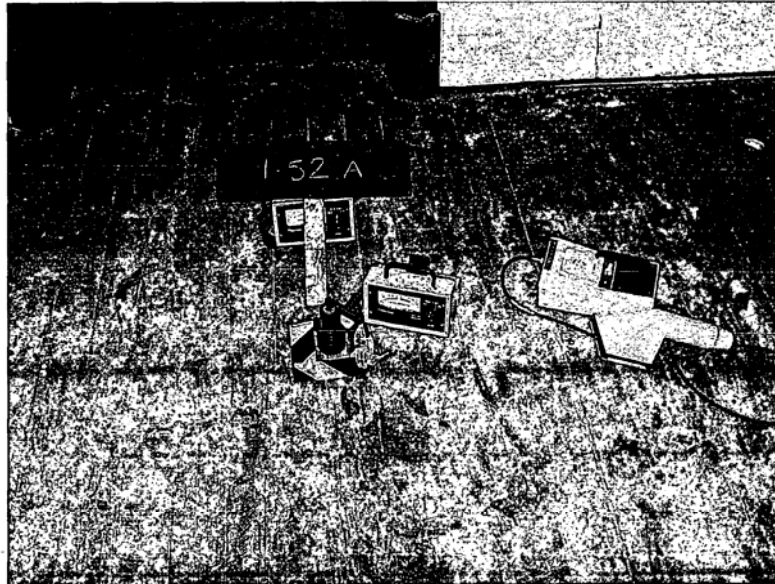
**6.4 Contaminated Areas in 1.52**

| Room | Coordinate | Identifier | Alpha cps | Beta cps | Gamma cps |
|---|---|---|---|---|---|
| 1.52 | F (0,1) | A | 0 | 700 | 200 |

| Room | Coordinate | Identifier | Alpha cps | Beta cps | Gamma cps | Radionuclide |
|---|---|---|---|---|---|---|
| 1.52 | F (0,1) | A | 0 | 700 | 200 | Ra-226 |

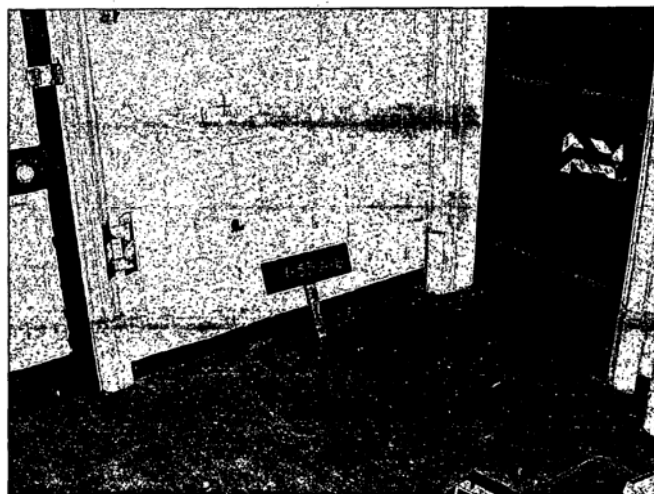
**6.5 Contaminated Areas in 1.53**

| Room | Coordinate | Identifier | Alpha cps | Beta cps | Gamma cps |
|---|---|---|---|---|---|
| 1.53 | SW (1,0) | A | 0 (painted) | 60 | 40 |
| | WW (0,0) | B | 0 (Painted) | 10 | (4-5 =bgd) |

| Room | Coordinate | Identifier | Alpha cps | Beta cps | Gamma cps | Radionuclide |
|---|---|---|---|---|---|---|
| 1.53 | SW (1,0) | A | 0 (painted) | 60 | 40 | Ra-226 |

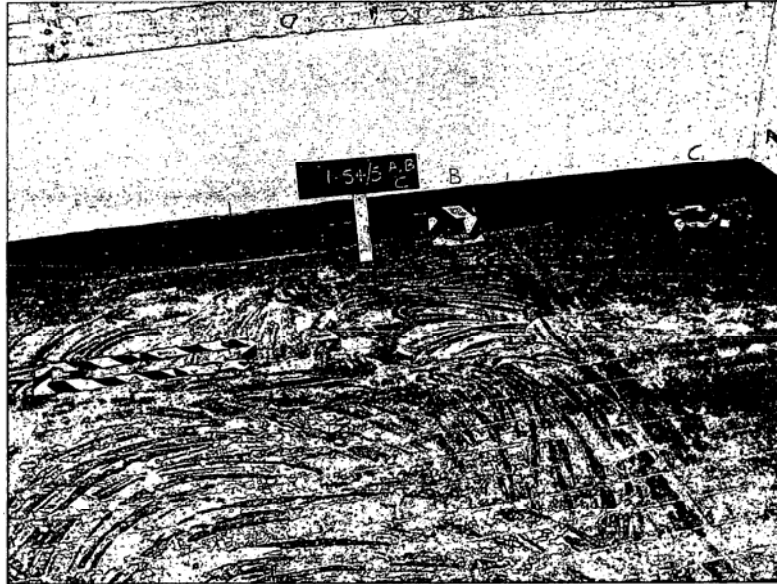
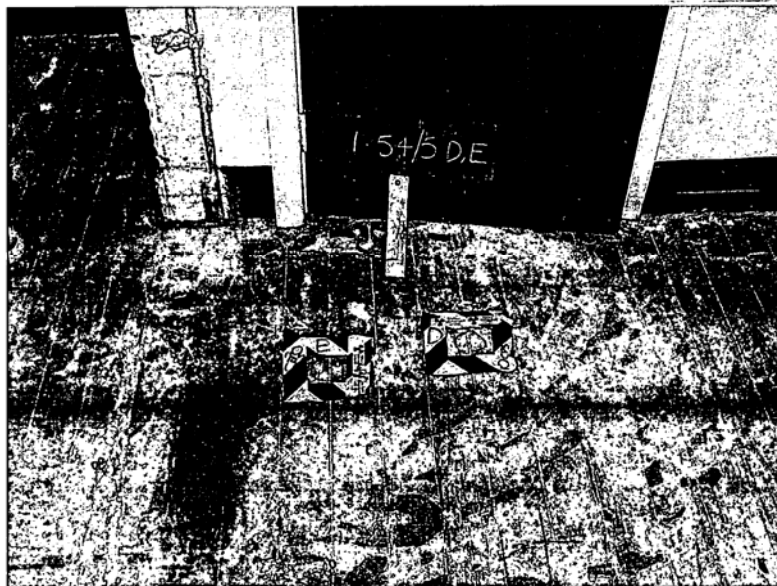
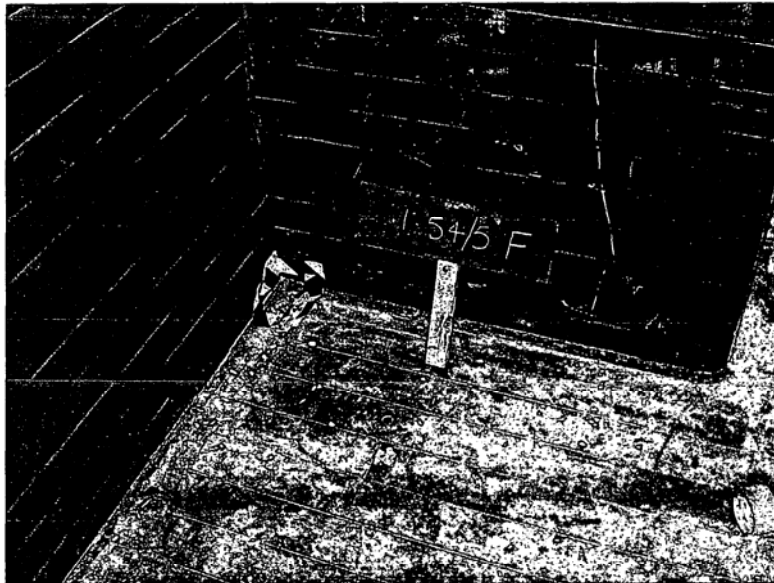
6.6 Contaminated Areas in 1.54/1.55

| Room | Coordinate | Identifier | Alpha cps | Beta cps | Gamma cps |
|---|---|---|---|---|---|
| 1.54/1.55 | F (8,0) | A | 0.5 | 20 | 9 |
| | F (8,1) | B | 0 | 10 | 9 |
| | F (7,2) | C | 0 | 250 | 80 |
| | F (4,4) | D | 0 | 10 | 7 |
| | F (4,4) | E | 0 | 20 | 10 |
| | F (4,5) | F | 0 | 100 | 20 |

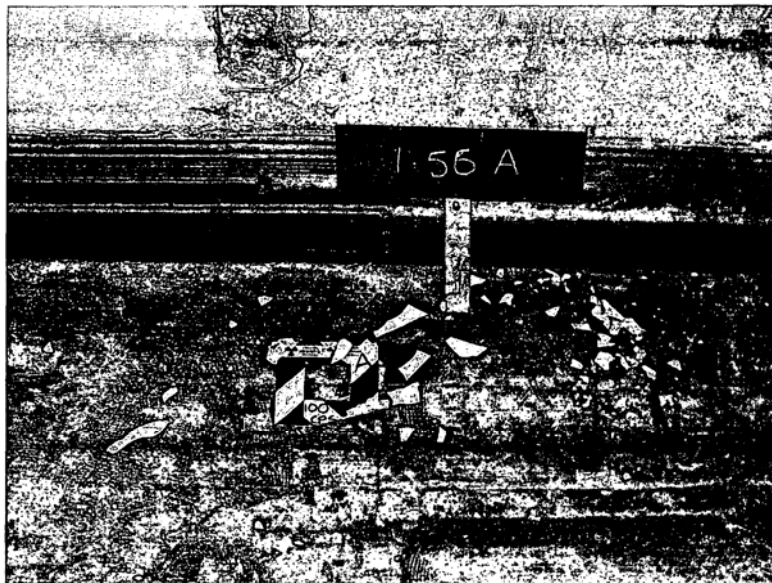
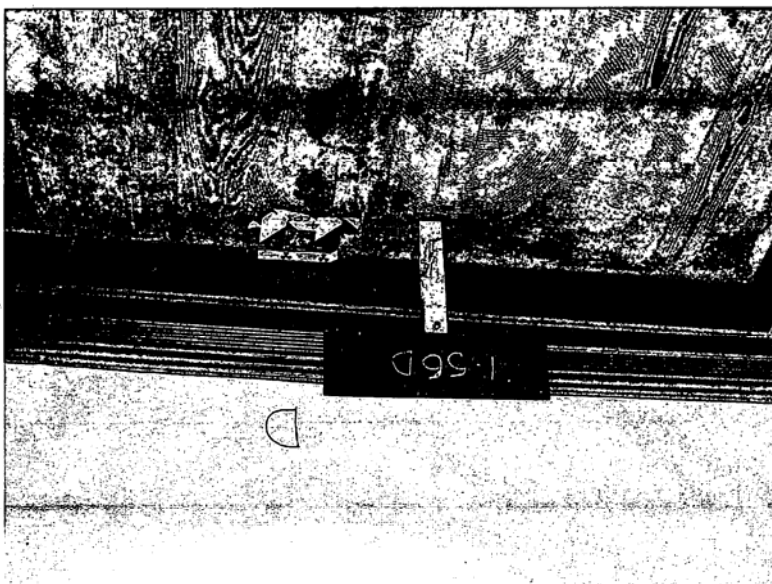
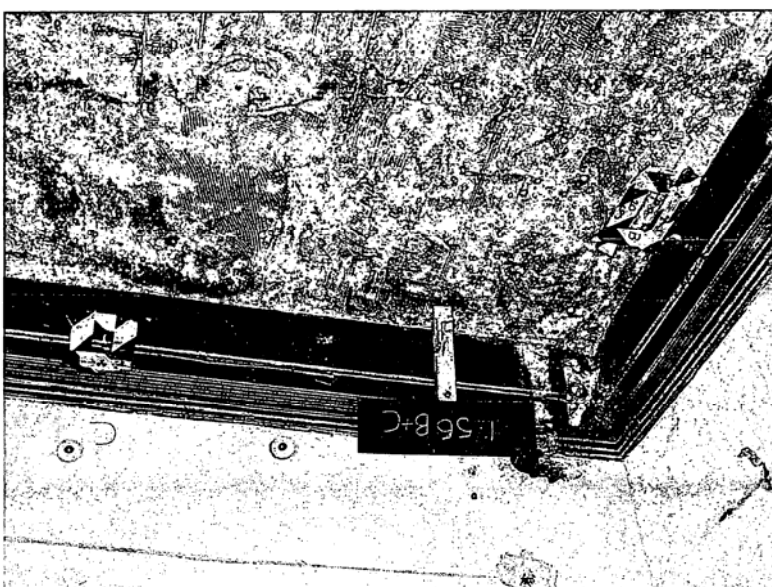
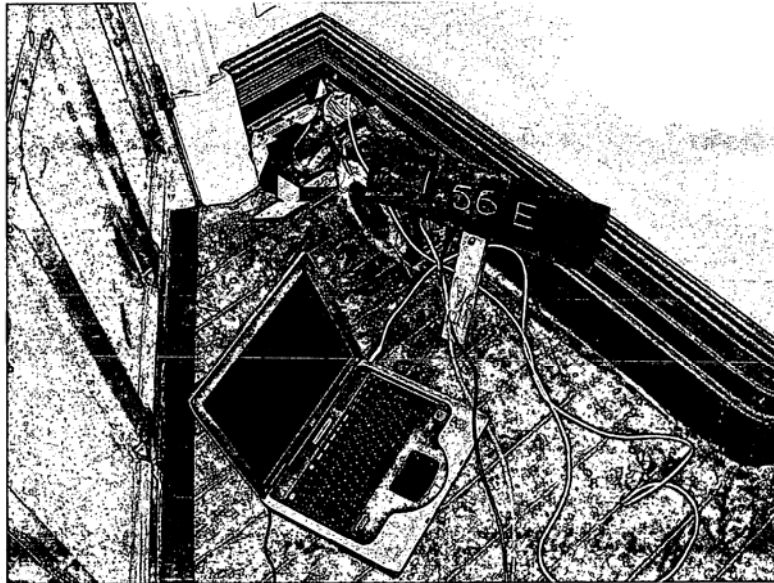
6.7 Contaminated Areas in 1.56

| Room | Coordinate | Identifier | Alpha cps | Beta cps | Gamma cps |
|---|---|---|---|---|---|
| | F (2,0) | A | 0.5 | 120 | 50 |
| 1.56 | F (0,0) | B | 0.5 | 15 | (4-5 =bgd) |
| | WW (1,0) | C | 0 | 30 | 20 |
| | F (3,3) | D | | 4 | (4-5 =bgd) |
| | F (1,5) | E | 0 | 50 | 100 |

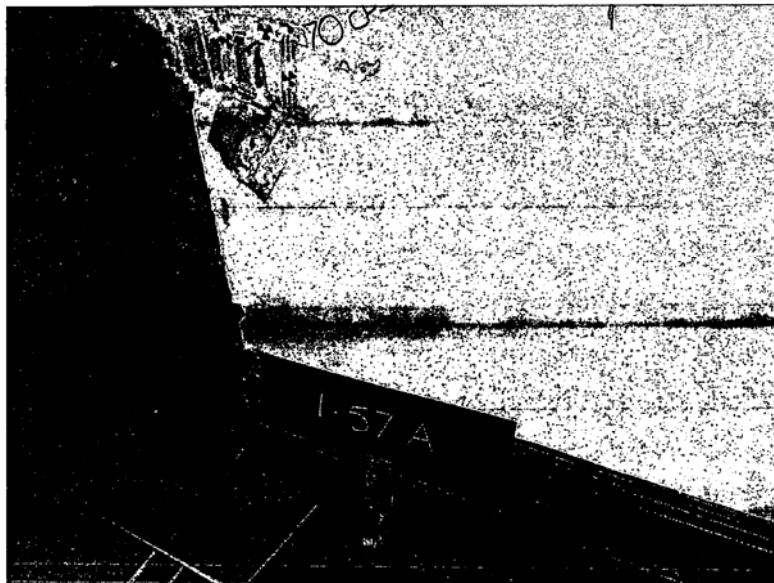
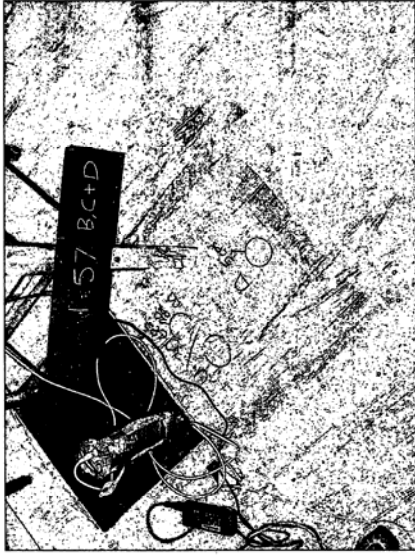
6.8 Contaminated Areas in 1.57

| Room | Coordinate | Identifier | Alpha cps | Beta cps | Gamma cps |
|---|---|---|---|---|---|
| | WW (0,0) | A | 0 | 70 | 30 |
| 1.57 | F (1,4) * | B | 0 | 20 | 20 |
| | F (1,4) * | C | 0 | 30 | 40 |
| | F (1,4) * | D | 0 | 5 | 9 |

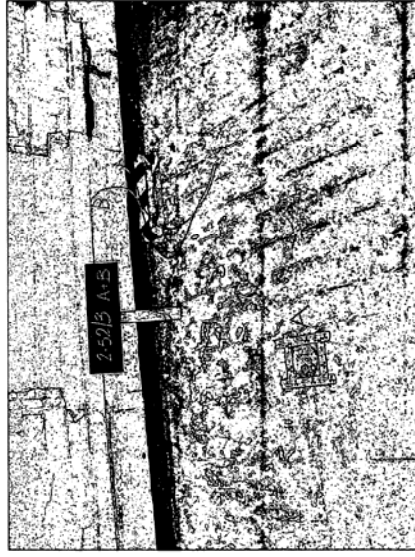
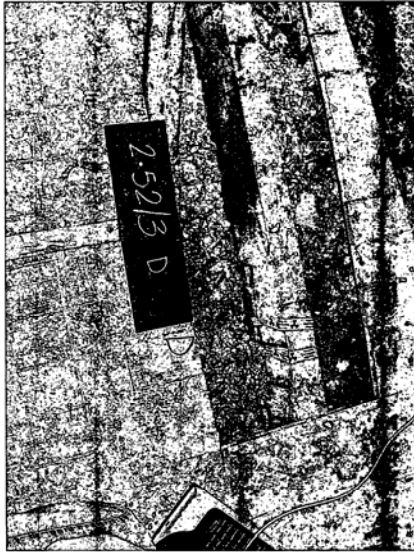
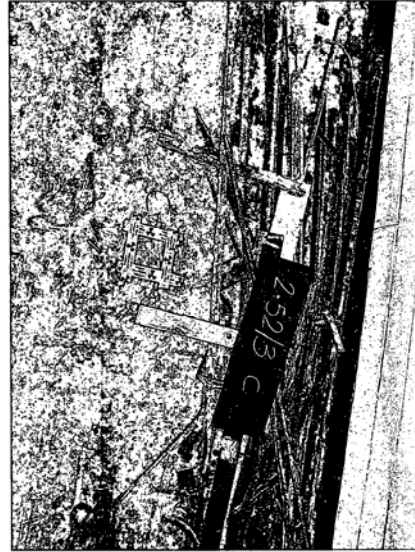
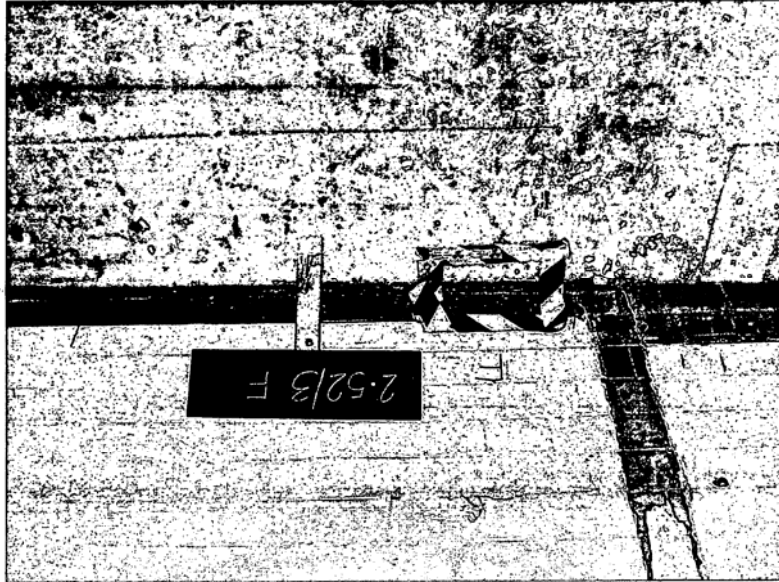
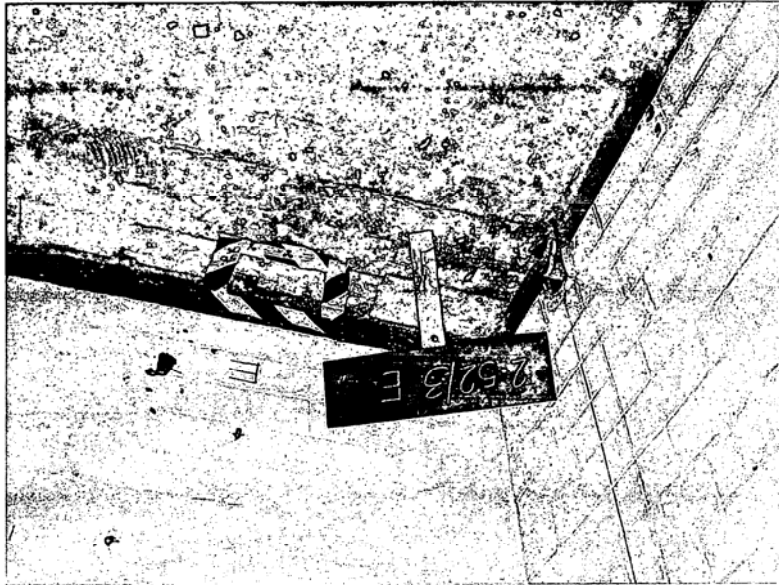
6.9 Contaminated Areas 2.52 / 2.53

| Room | Coordinate | Identifier | Alpha cps | Beta cps | Gamma cps |
|---|---|---|---|---|---|
| 2.52/2.53 | F (2,5) | A | 0 | 60 | 40 |
| | F (2,6) | B | 5 | 30 | 15 |
| | F (4,3) | C | 0 | 50 | 50 |
| | F (2,4) | D | 300 | 2000 | 250 |
| | F (0,0) | E | 0 | 50 | 10 |
| | F (3,0) | F | 0 | 5 | 5 |

Exceptions to this were the more extensively contaminated areas in Room 2.62, and two areas where the level of contamination was significantly higher than that typical for the building. These areas were in Room 2.52/2.53 Floor (2,4) Area D and The Beekeepers Floor (4,2) Area A.

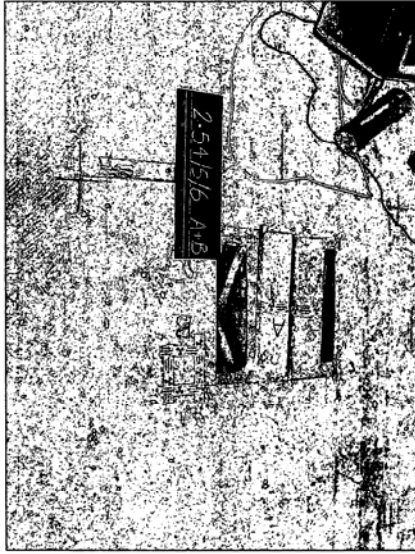
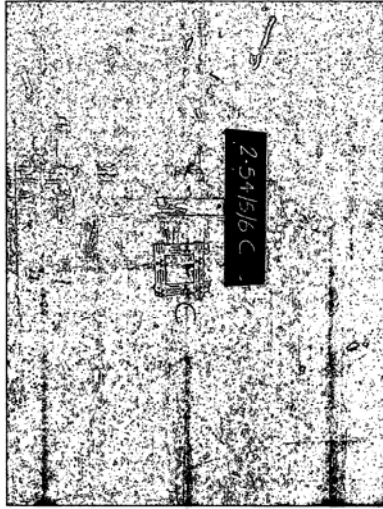
6.10 Contaminated Areas in 2.54 / 2.55 / 2.56

| Room | Coordinate | Identifier | Alpha cps | Beta cps | Gamma cps |
|---|---|---|---|---|---|
| 2.54/2.55/2.56 | F (1,3) | A (BENEATH FLOOR) | 0 | 150 | 15 |
| | F (1,3) | b Floorboard | 0 | 20 | 15 |
| | F (4,1) | C | 0 | 10 | 4 |

| Room | Coordinate | Identifier | Alpha cps | Beta cps | Gamma cps |
|---|---|---|---|---|---|
| | C (1,4) | D (CEILING) | | 3 | 8 |

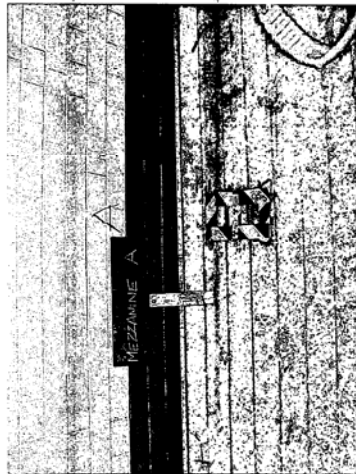
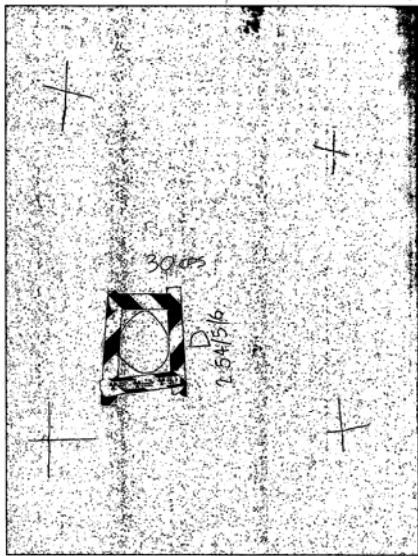
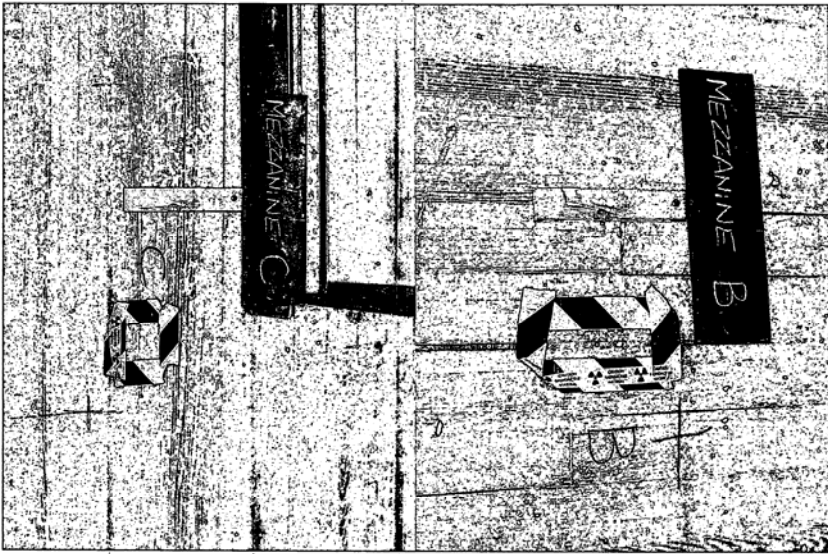
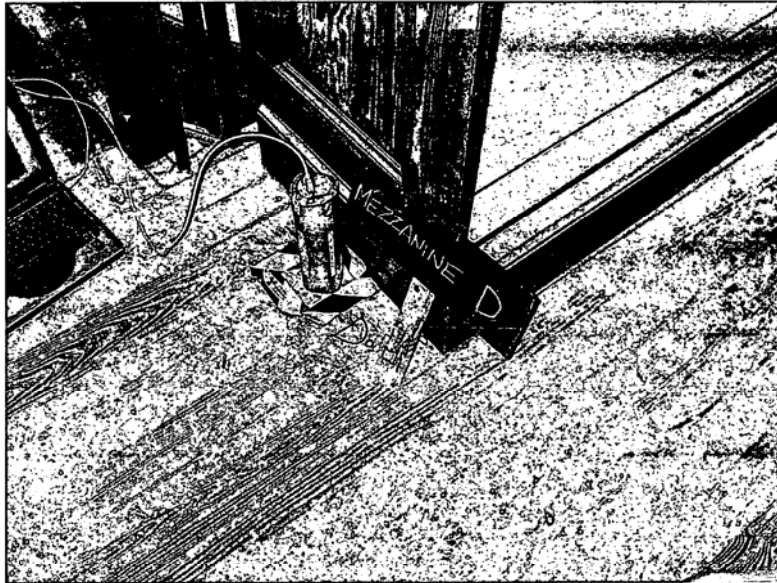
6.11 Contaminated Areas in Mezzanine Area

| Room | Coordinate | Identifier | Alpha cps | Beta cps | Gamma cps |
|---|---|---|---|---|---|
| Mezzanine | F (9,3) | A | 0.5 | 30 | 8 |
| | F (5,1) | B | 0.5 | 8 | 7 |
| | F (3,4) | C | 40 | 100 | 20 |
| | F (3,5) | D | 1.5 | 100 | 30 |

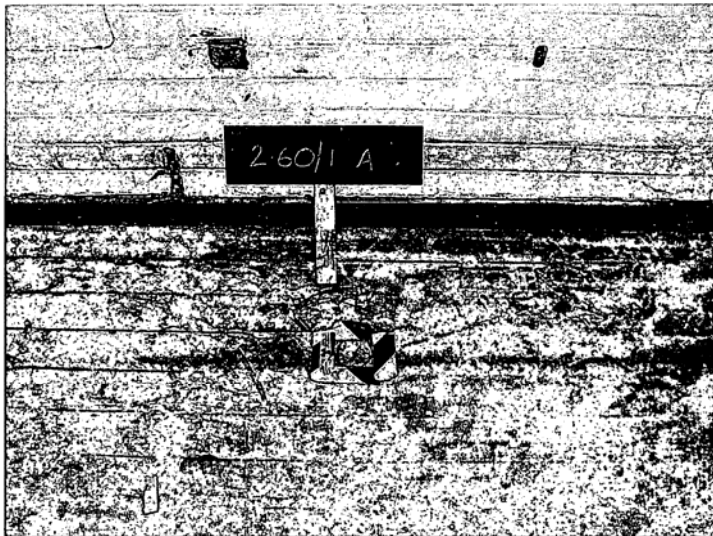
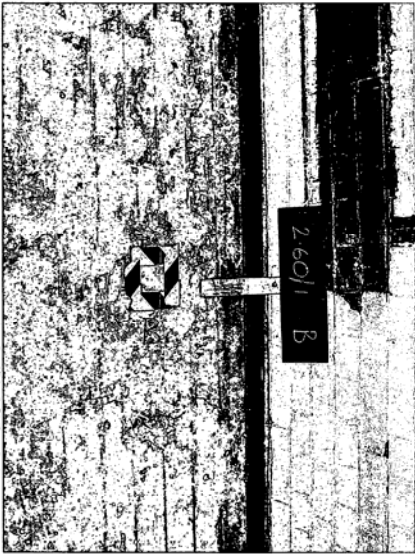
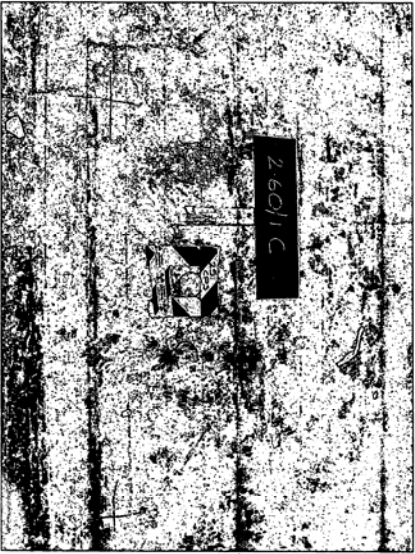
**6.12 Contaminated Areas in 2.60/2.61**

| Room | Coordinate | Identifier | Alpha cps | Beta cps | Gamma cps |
|---|---|---|---|---|---|
| 2.60/61 | F (8,0) | A | 0 | 15 | 10 |
| | F (8,2) | B | 0 | 200 | 70 |
| | F (4,5) | C | 0 | 30 | 10 |

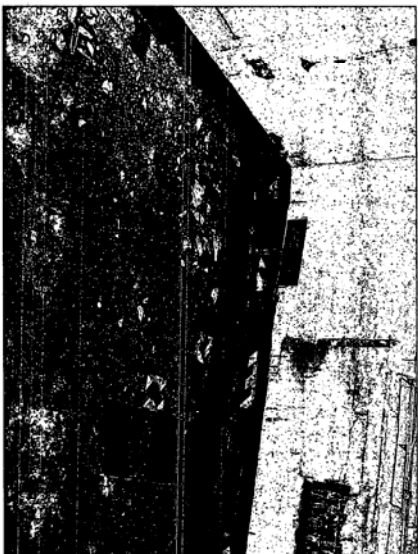
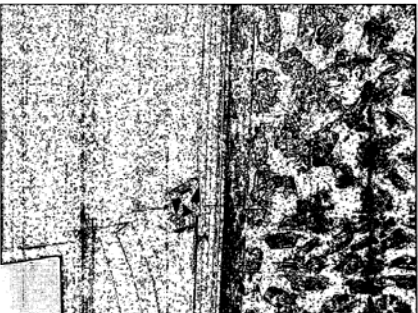
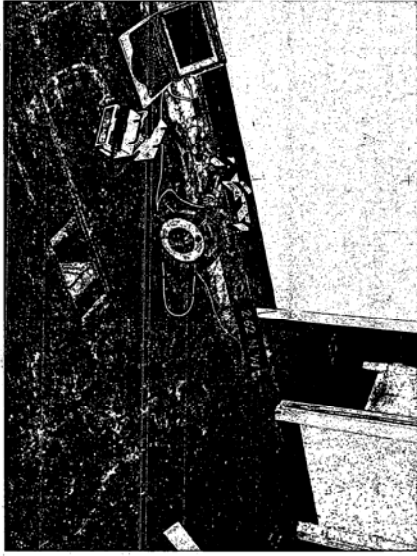
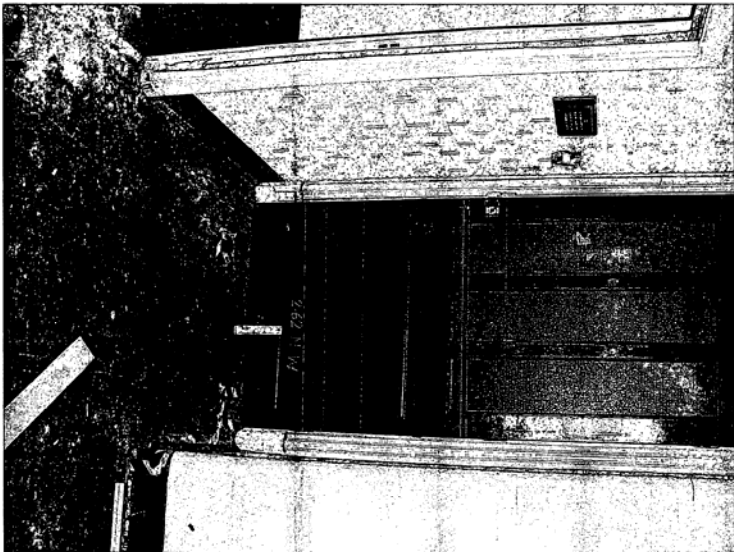
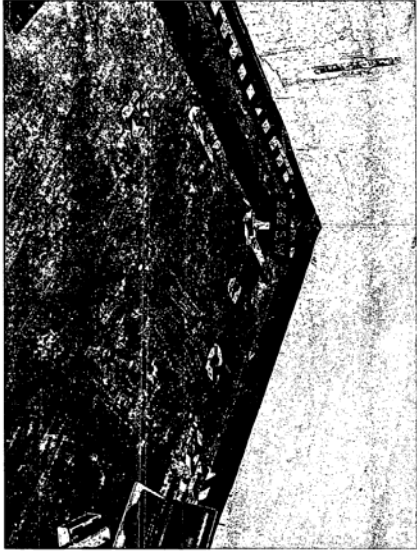
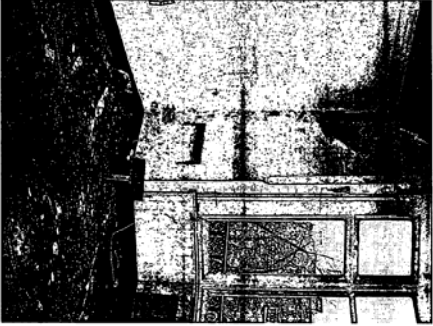
6.13 Contaminated Areas in 2.62

| Room | Coordinate | Identifier | Alpha cps | Beta cps | Gamma cps |
|---|---|---|---|---|---|
| 2.62 | | Many areas | 0-50 | 05-10 | |
| | WW (3,0) | West wall | 40 | 100 | 20 |

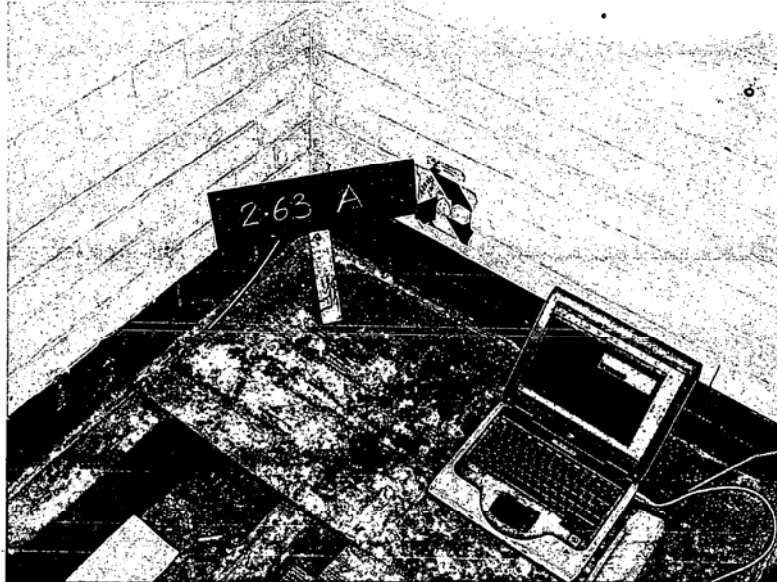
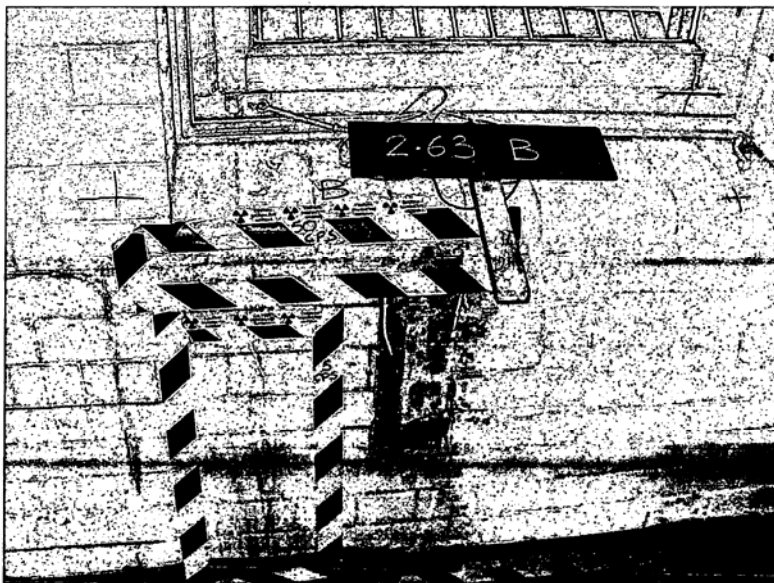
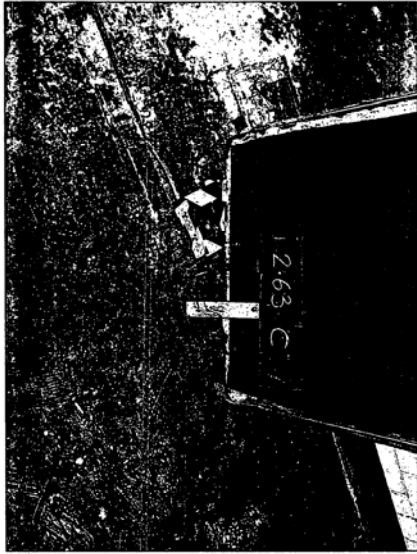
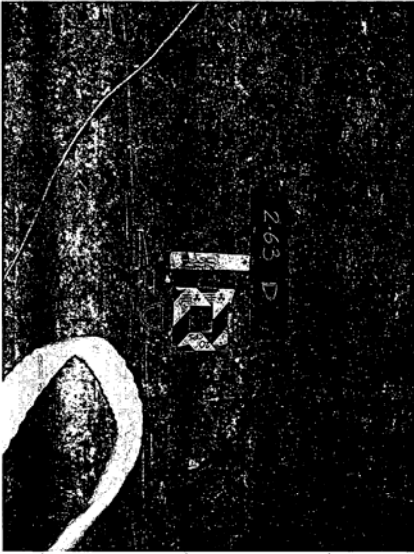
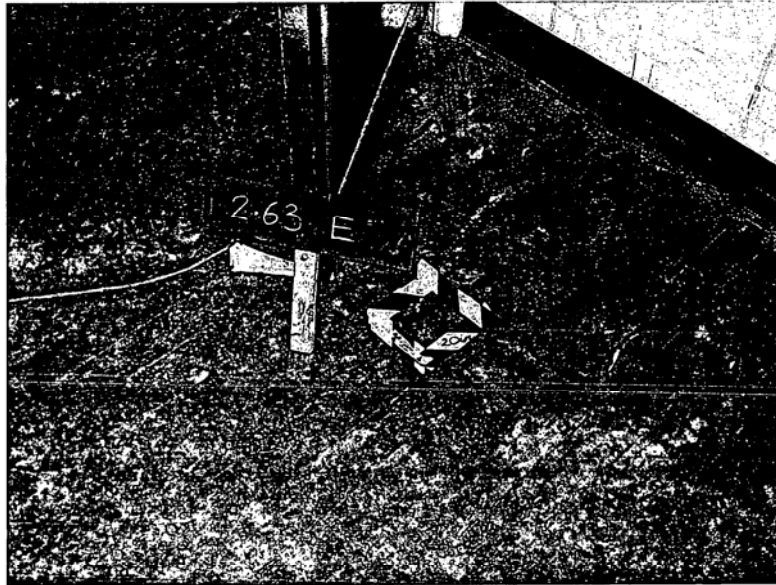
6.14 Contaminated Areas in 2.63

| Room | Coordinate | Identifier | Alpha cps | Beta cps | Gamma cps |
|---|---|---|---|---|---|
| 2.63 | WW (0,0) | A | 0 | 400 | 150 |
| | SW (1,0) | B | 0 | 50 | 20 |
| | F (3,3) | C | 0.5 | 20 | 9 |
| | F (1,3) | D | 0 | 20 | 20 |
| | F (3,5) | E | 0 | 20 | 20 |

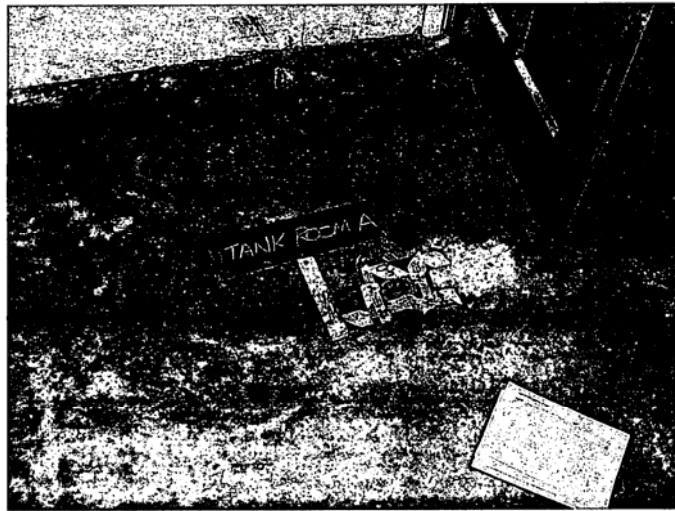
#### 6.15 Contaminated Areas in the Tank Room

| Room | Coordinate | Identifier | Alpha cps | Beta cps | Gamma cps |
|---|---|---|---|---|---|
| Tank room | F (0,3) | A | 0.5 | 40 | 10 |

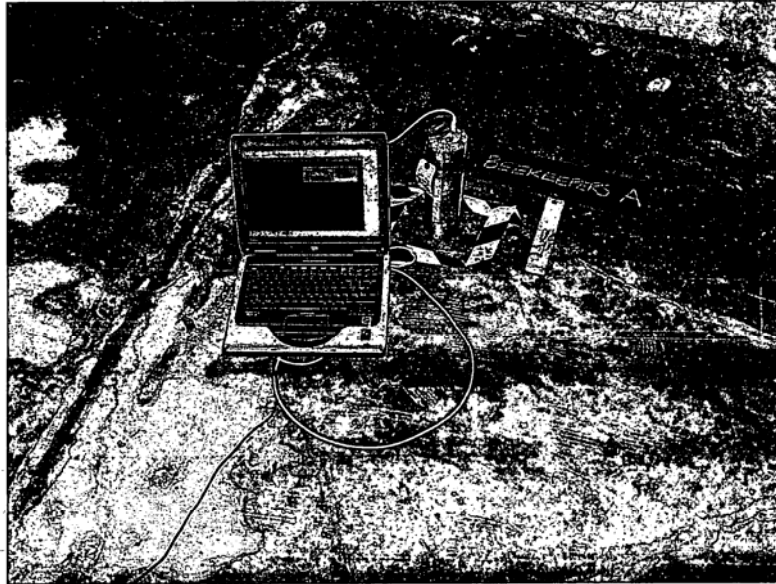
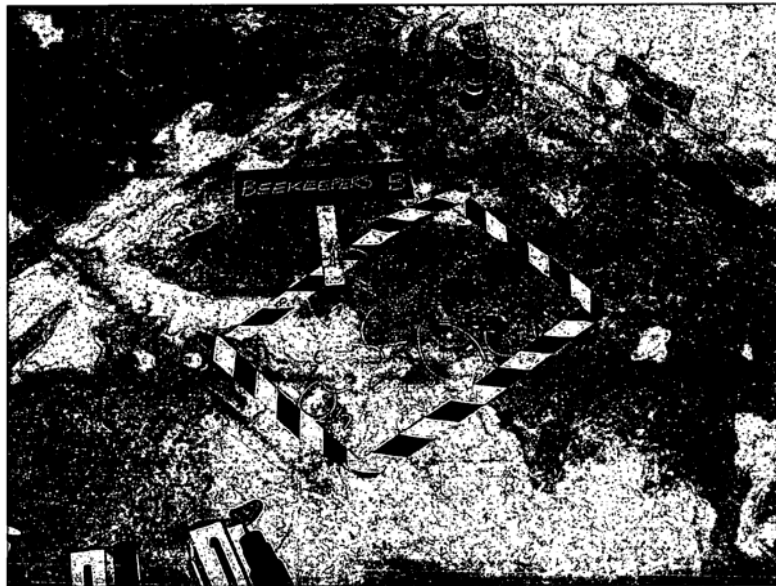
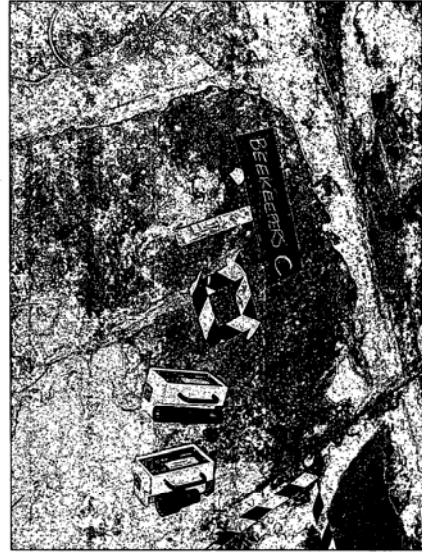
6.16 Contaminated Areas in the Beekeepers

| Room | Coordinate | Identifier | Alpha cps | Beta cps | Gamma cps |
|---|---|---|---|---|---|
| Beekeepers | F (4,2) | A | 1 | 2000 | 600 |
| | F (2,0) | B | 0.5 | 100 | 20 |
| | F (2,1) | C | 0 | 7 | 4-5 (=bgd) |
