Final Report

**SURVEY OF THE PRESENCE OF
MERCURY RESIDUES WITHIN THE
COUPLAND BUILDING, MANCHESTER
UNIVERSITY.**

Project number – FLIX0010

Manchester University Design Services Group
4th floor Beyer Building,
Oxford Road
Manchester.
M13 9PL

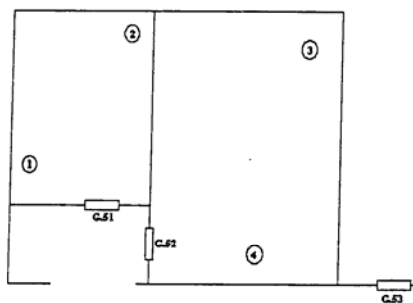
Room number – G51 & G52

Sample number	Mercury reading	sample description
1	0.5	sub-floor
2	0.9	sub-floor
3	1.0	sub-floor
4	1.1	sub-floor
B/G	0.1	ambient air

No specific actions are recommended for these areas.

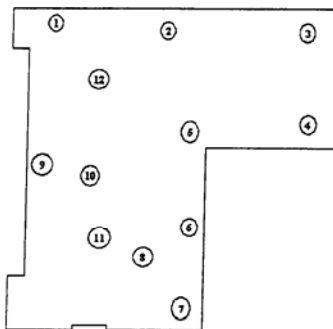
Room number – G53

Sample number	Mercury reading	sample description
1	90.8	sub-floor
2	173.8	sub-floor
3	44.0	sub-floor
4	64.1	sub-floor
5	162.1	sub-floor
6	17.0	sub-floor
7	94.8	sub-floor
8	102.0	sub-floor
9	232.8	sub-floor
10	192.0	sub-floor
11	181.5	sub-floor
12	74.7	sub-floor
B/G	1.6	ambient air

The floor boards should be removed and the sub-floor area cleaned of all visible mercury residues and other material that may have been contaminated by mercury. The entire sub-floor area should be cleaned and the flooring replaced with new boarding. During this process appropriate PPE including gloves, eye protection and respiratory protection should be used. It is strongly recommended that air monitoring is undertaken during and after these procedures to ensure the removal procedures are not generating a hazardous level of mercury vapour.

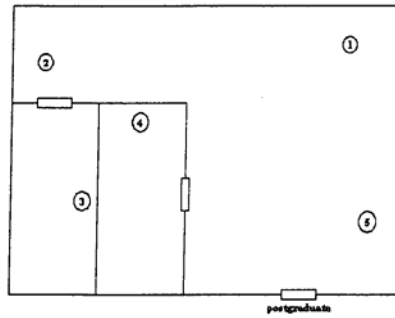
Room number – postgraduate room

Sample number	Mercury reading	sample description
1	2.0	sub-floor
2	11.3	sub-floor
3	33.4	sub-floor
4	15.1	sub-floor
5	16.7	sub-floor
B/G	1.4	ambient air

The floor boards should be removed and the sub-floor area cleaned of all visible mercury residues and material that may have been contaminated by mercury. The original flooring should then be replaced. During this process appropriate PPE including gloves, eye protection and respiratory protection should be used. It is strongly recommended that air monitoring is undertaken during and after these procedures to ensure the removal procedures are not generating a hazardous level of mercury vapour.

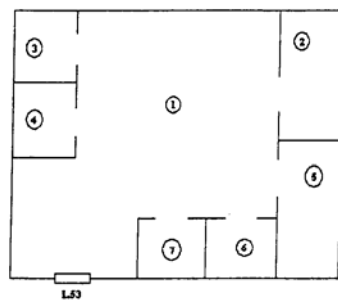
Room number – 1.53

Sample number	Mercury reading	sample description
1	5.2	sub-floor
2	7.3	sub-floor
3	20.0	sub-floor
4	2.4	sub-floor
5	3.0	sub-floor
6	1.4	sub-floor
7	1.5	sub-floor
B/G	1.6	ambient air

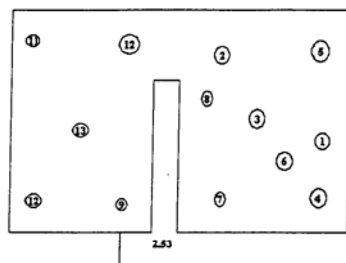
Room number – 2.53

- 4.4.1 In three instances (room no1.52 location 5 and room 2.53 locations 1 and 7) there was a significant ($>25\mu\text{g}/\text{m}^3$) level of mercury vapour present associated with the wood dust from the sample access hole. Samples of material were taken from these locations, along with a comparison sample taken from room 1.52 location 4. The results of the analysis of the wood dust samples indicate that there are significantly elevated levels of mercury present within the board material in the sample locations compared to the comparison sample. This may indicate that in these rooms there is a likelihood that mercury spillages took place which have left residues either on the surface of the floor boards or within the structure of the boards.
- 4.4.2 It is suggested that in these two rooms the entire floor is removed and replaced with new flooring.

Sample number	Mercury reading	sample description
1	26.5	sub-floor
2	16.6	sub-floor
3	15.4	sub-floor
4	12.6	sub-floor
5	5.6	sub-floor
6	15.9	sub-floor
7	18.3	sub-floor
8	35.3	sub-floor
9	3.9	sub-floor
10	2.7	sub-floor
11	5.5	sub-floor
12	7.0	sub-floor
13	5.5	sub-floor
B/G (left)	3.9	ambient air
B/G (right)	3.3	ambient air

Sample number	room number	location	mercury (mg/kg)
1	2.53	1	1340
2	2.53	7	597
3*	2.53	4	4.8*
4	1.52	5	216

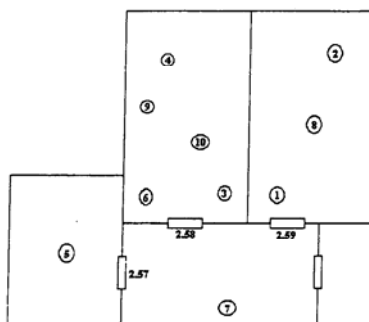
Room number – 2.57, 2.58, 2.59

Sample number	Mercury reading	sample description
1 (2.59)	1.4	sub-floor
2 (2.59)	0.6	sub-floor
3 (2.58)	1.4	sub-floor
4 (2.58)	4.9	sub-floor
5 (2.57)	0.3	sub-floor
6 (2.58)	5.6	sub-floor
7 (corridor)	1.0	sub-floor
8 (2.59)	1.6	sub-floor
9 (2.58)	3.7	sub-floor
10 (2.58)	17.6	sub-floor
B/G (2.57)	0.7	ambient air
B/G (2.58)	1.0	ambient air
B/G (2.59)	0.3	ambient air

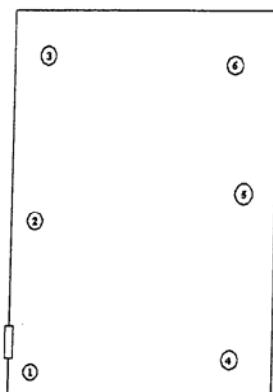
Room number – (2.61)

Sample number	Mercury reading	sample description
1	10.8	sub-floor
2	18.8	sub-floor
3	1.2	sub-floor
4	1.2	sub-floor
5	0.6	sub-floor
6	0.5	sub-floor
B/G	0.9	ambient air

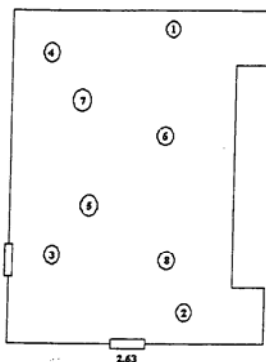
Room number – 2.63

The main areas of contamination are within rooms 2.52 and 2.52A, 2.62 and 2.63, and G53. The sub-floor areas within room 2.62 where floorboards have been removed contained a significant amount of visible mercury.

Sample number	Mercury reading	sample description
1	6.5	sub-floor
2	67.8	sub-floor
3	62.3	sub-floor
4	12.2	sub-floor
5	185.8	sub-floor
6	370.0	sub-floor
7	48.9	sub-floor
8	120.0	sub-floor
B/G	4.9	ambient air

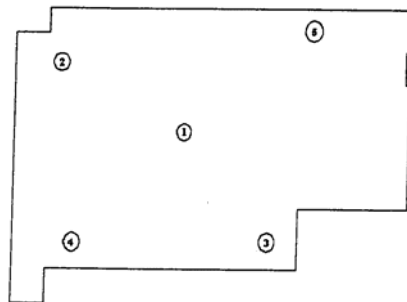
Room number – 2.64

Sample number	Mercury reading	sample description
1	0.6	sub-floor
2	1.0	sub-floor
3	0.8	sub-floor
4	0.4	sub-floor
5	0.3	sub-floor
6	0.5	sub-floor
B/G	0.6	ambient air
